# Access Compliance Report Public Rights-of-Way (Curb Ramps)

Main Street: VINEYARD\_RD Cross Street: ROANOKE\_DR Location: SW

ADA ID: RPAT211103111757 Ramp Type: Type 1 - Perpendicular Diagonal Initial Pass/Fail: Fail Overall Compliance: No Severity Score: 0

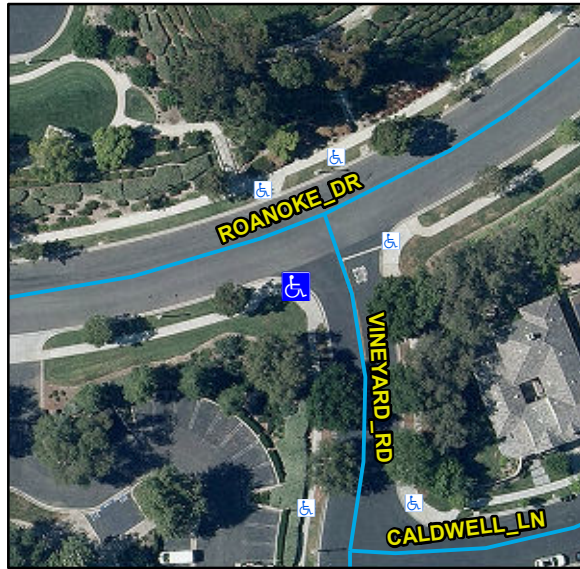
| Compliance | Description | Data | Compliance | Description | Data |
|---|---|---|---|---|---|
| N/A | Gutter Ponding | No | No | Curb Slope | 12.6 |

**Remove & Replace Curb Ramp With Two New Directional Ramps or Equivalent.**

**R304.2.2, R204.3, STD 1115**
