# Access Compliance Report Public Rights-of-Way (Curb Ramps)

| Main Street: ROANOKE_DR | | Cross Street: VINEYARD_RD | | Location: | NW |
| ADA ID: RPAT211103112126 | Ramp Type:Type 1 - Perpendicular | Initial Pass/Fail: Fail | Overall Compliance: No | Severity Score: | 2 |

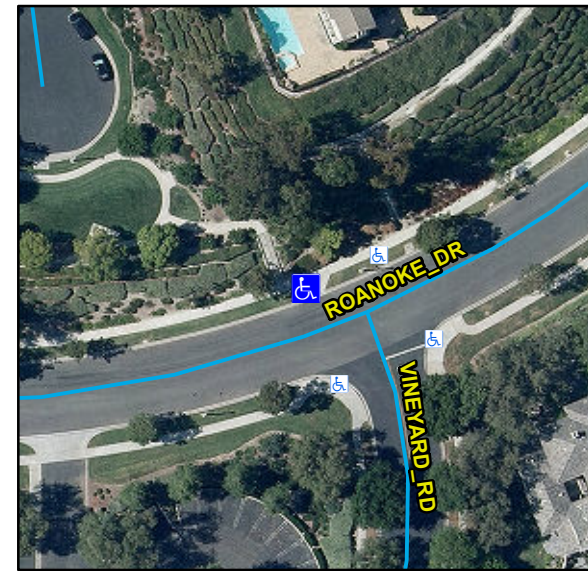
| Compliance | Description | Data | Compliance | Description | Data |
|---|---|---|---|---|---|
| No | Ramp Cross Slope (%) | 4.4 | N/A | Flare Traversable LT | N/A |
| N/A | Gutter Ponding | N/A | No | Curb Slope | 13.7 |

Remove & Replace Entire Ramp.

R304.2.2, R204.3, R304.5.3, STD 1115
