# Access Compliance Report Public Rights-of-Way (Curb Ramps)

Main Street: VINEYARD\_RD Cross Street: CALDWELL\_LN Location: NE

ADA ID: RPAT211103112451 Ramp Type: Type 4 - Parallel Initial Pass/Fail: Fail Overall Compliance: No Severity Score: 16

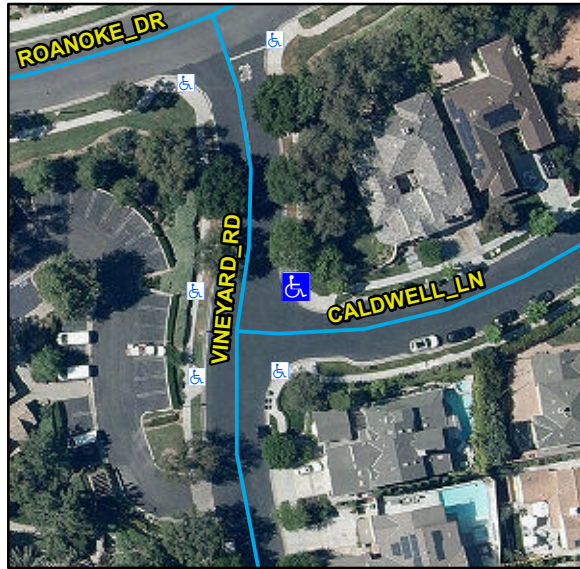
| Compliance | Description | Data | Compliance | Description | Data |
|---|---|---|---|---|---|
| No | Ramp Run Slope LT (%) | 12 | Yes | Ramp Run Slope RT (%) | 1.4 |
| No | Ramp Cross Slope LT (%) | 2.9 | Yes | Ramp Cross Slope RT (%) | 1.4 |

Remove & Replace Curb Ramp With Two New Directional Ramps or Equivalent.
