# Access Compliance Report Public Rights-of-Way (Curb Ramps)

| Main Street: CALDWELL_LN | | Cross Street: VINEYARD_RD | | Location: | SE |
| ADA ID: RPAT211103112719 | Ramp Type: Type 4 - Parallel | Initial Pass/Fail: Fail | Overall Compliance: No | Severity Score: | 2 |

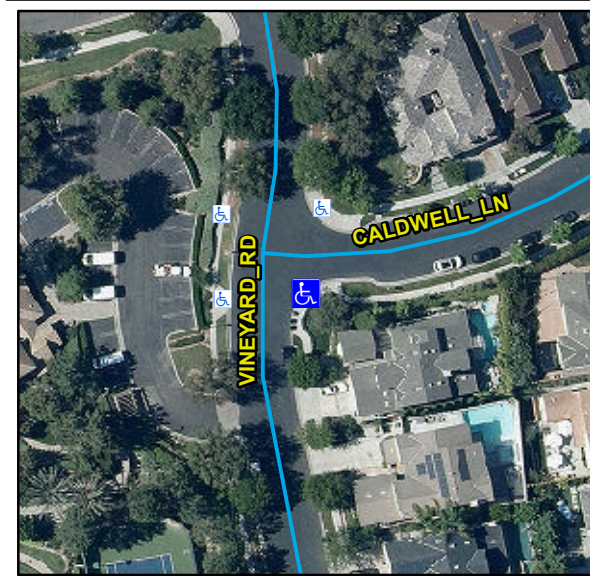
| Compliance | Description | Data | Compliance | Description | Data |
|---|---|---|---|---|---|
| No | Ramp Cross Slope LT (%) | 2.4 | No | Ramp Cross Slope RT (%) | 2.5 |

**Remove & Replace Curb Ramp With Two New Directional Ramps or Equivalent.**

**R204.3, R304.5.3, STD 1115**

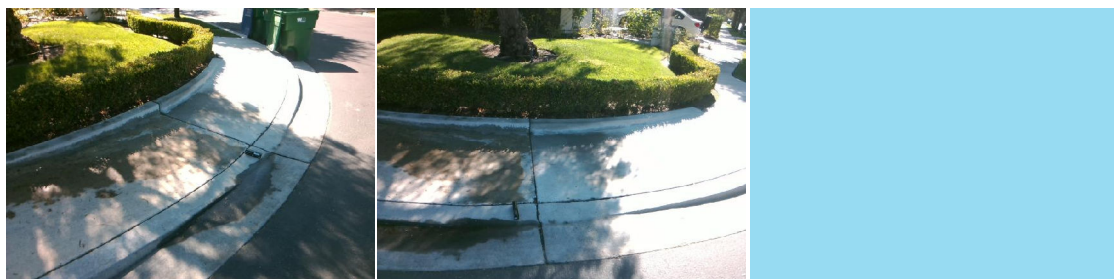
| Compliance | Description | Data | Compliance | Description | Data |
|---|---|---|---|---|---|
| N/A | Ramp Length LT (in) | 107 | N/A | Ramp Length RT (in) | 105 |
| Yes | Ramp Width LT (in) | 52 | Yes | Ramp Width RT (in) | 52 |
| Yes | Ramp Run Slope LT (%) | 5.3 | Yes | Ramp Run Slope RT (%) | 3.1 |
