# Access Compliance Report Public Rights-of-Way (Curb Ramps)

| Main Street: VINEYARD_RD | | Cross Street: CALDWELL_LN | | Location: | SW |
| ADA ID: RPAT211103113020 | Ramp Type:Type 1 - Perpendicular | Initial Pass/Fail: Fail | Overall Compliance: No | Severity Score: | 16 |

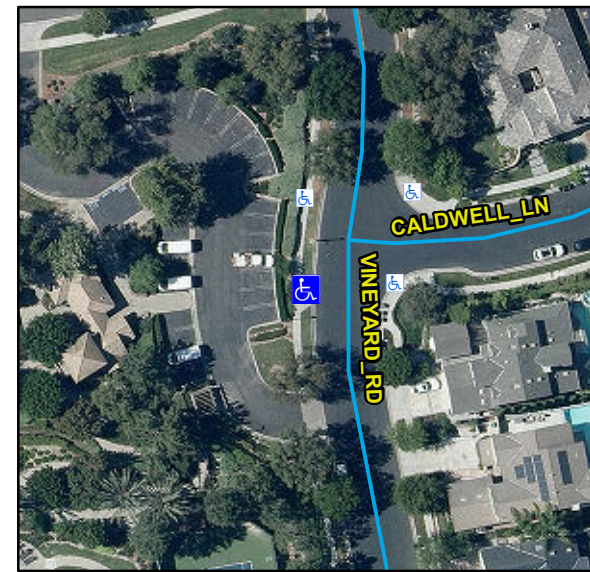
| Compliance | Description | Data | Compliance | Description | Data |
|---|---|---|---|---|---|
| No | Ramp Run Slope (%) | 10.5 | N/A | Flare Slope LT (%) | N/A |
| No | Ramp Cross Slope (%) | 3.8 | N/A | Flare Traversable LT | N/A |

Remove & Replace Entire Ramp.
