# Access Compliance Report Public Rights-of-Way (Curb Ramps)

Main Street: MARKHAM\_LN Cross Street: CALDWELL\_LN Location: SW

ADA ID: RPAT211103113332 Ramp Type: Type 4 - Parallel Initial Pass/Fail: Fail Overall Compliance: No Severity Score: 15

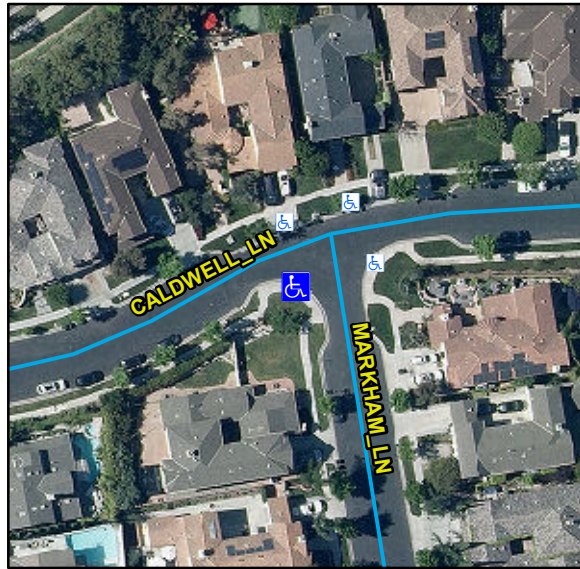
| Compliance | Description | Data | Compliance | Description | Data |
|---|---|---|---|---|---|
| Yes | Ramp Run Slope LT (%) | 0.8 | No | Ramp Run Slope RT (%) | 11.9 |

**Remove & Replace Curb Ramp With Two New Directional Ramps or Equivalent.**

**R204.3, R304.3.2, STD 1115**
