# Access Compliance Report Public Rights-of-Way (Curb Ramps)

Main Street: CALDWELL\_LN Cross Street: MARKHAM\_LN Location: SE

ADA ID: RPAT211103113703 Ramp Type: Type 4 - Parallel Initial Pass/Fail: Pass Overall Compliance: No Severity Score: 15

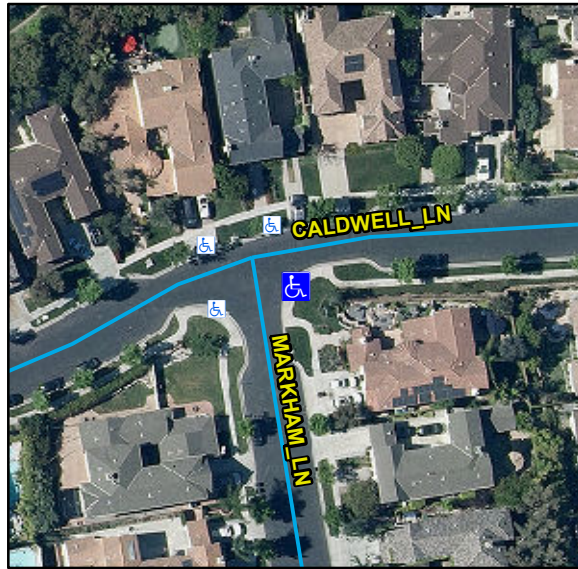
| Compliance | Description | Data | Compliance | Description | Data |
|---|---|---|---|---|---|
| N/A | Landing Present | Yes | No | DWS Provided | No |
| Yes | Gutter Ponding | No | No | Curb Slope | 14.8 |
| No | Gutter Run Slope (%) | 6.9 | | Road Cross Slope (%) | 3.7 |
| Yes | Gutter Cross Slope (%) | 0.7 | No | Perpendicular Joint Present | No |

Remove & Replace Curb Ramp With Two New Directional Ramps or Equivalent. Remove & Replace Gutter.

R304.2.2, R204.3, R305, R304.5.4, STD 1115
