# Access Compliance Report Public Rights-of-Way (Curb Ramps)

Main Street: FALKNER\_DR Cross Street: CALDWELL\_LN Location: SW

ADA ID: RPAT211103114338 Ramp Type: Type 4 - Parallel Initial Pass/Fail: Fail Overall Compliance: No Severity Score: 16

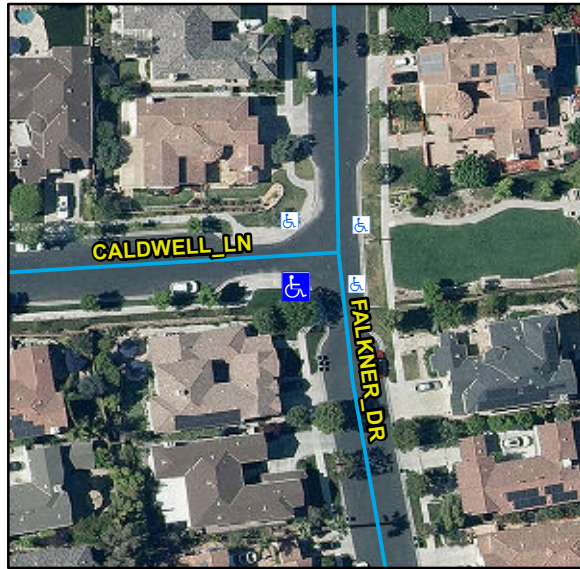
**R204.3, R304.5.3, R304.3.2, STD 1115**

| Compliance | Description | Data | Compliance | Description | Data |
|---|---|---|---|---|---|
| Yes | Ramp Run Slope LT (%) | 2.5 | No | Ramp Run Slope RT (%) | 9.9 |
| No | Ramp Cross Slope LT (%) | 2.6 | Yes | Ramp Cross Slope RT (%) | 1.7 |

**Remove & Replace Curb Ramp With Two New Directional Ramps or Equivalent.**

Total Cost: \$ 4000
