# Access Compliance Report Public Rights-of-Way (Curb Ramps)

Main Street: CALDWELL\_LN Cross Street: FALKNER\_DR Location: NW

ADA ID: RPAT211103114627 Ramp Type: Type 4 - Parallel Initial Pass/Fail: Pass Overall Compliance: No Severity Score: 15

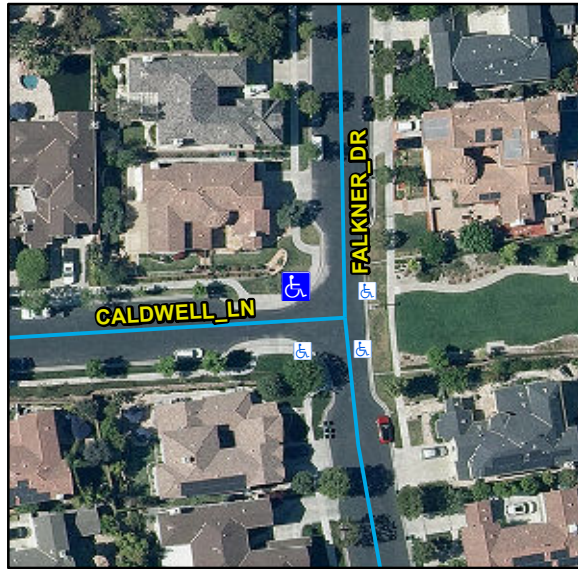
| Compliance | Description | Data | Compliance | Description | Data |
|---|---|---|---|---|---|
| N/A | Landing Present | Yes | No | DWS Provided | No |
| Yes | Gutter Ponding | No | No | Curb Slope | 13.4 |
| No | Gutter Run Slope (%) | 8.5 | | Road Cross Slope (%) | 0.1 |

Remove & Replace Curb Ramp With Two New Directional Ramps or Equivalent. Remove & Replace Gutter.

R304.2.2, R204.3, R305, R304.5.4, STD 1115
