# Access Compliance Report Public Rights-of-Way (Curb Ramps)

Main Street: DOWNING\_ST Cross Street: TUDOR\_WAY Location: N

ADA ID: RPAT211103131311 Ramp Type: Type 4 - Parallel Initial Pass/Fail: Fail Overall Compliance: No Severity Score: 15

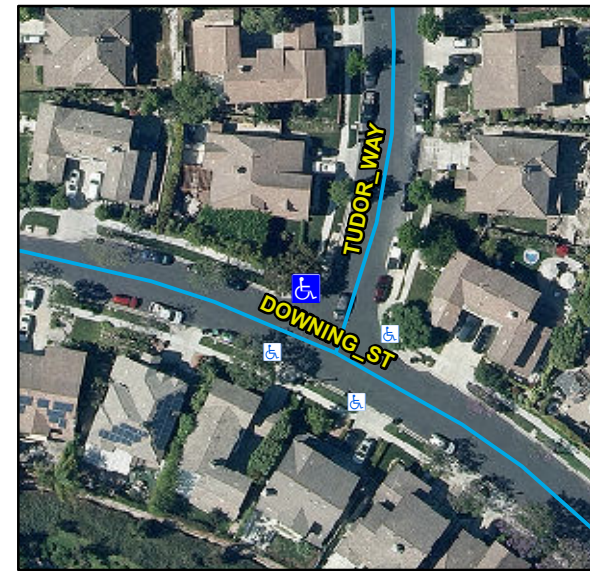
| Compliance | Description | Data | Compliance | Description | Data |
|---|---|---|---|---|---|
| No | Ramp Cross Slope LT (%) | 5.3 | Yes | Ramp Cross Slope RT (%) | 0.5 |
| N/A | Gutter Ponding | N/A | No | Curb Slope | 12.8 |
| N/A | Gutter Cross Slope (%) | N/A | No | Perpendicular Joint Present | No |

**Remove & Replace Curb Ramp With Two New Directional Ramps or Equivalent.**

**R304.2.2, R204.3, R304.5.3, STD 1115**
