# Access Compliance Report Public Rights-of-Way (Curb Ramps)

Main Street: TUDOR\_WAY Cross Street: DOWNING\_ST Location: E

ADA ID: RPAT211103131600 Ramp Type: Type 4 - Parallel Initial Pass/Fail: Fail Overall Compliance: No Severity Score: 2

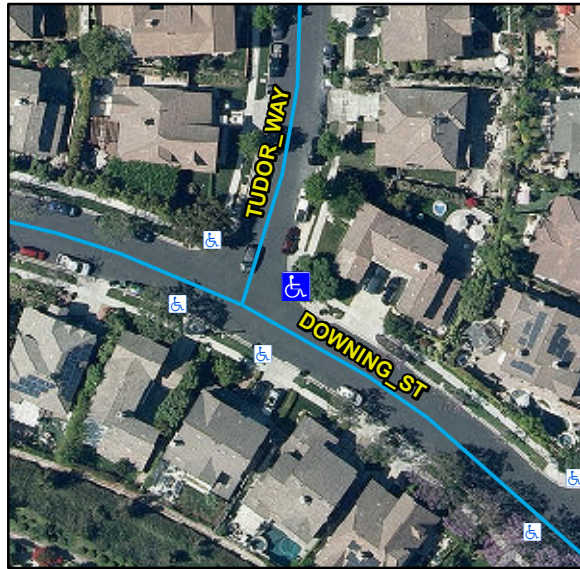
| Compliance | Description | Data | Compliance | Description | Data |
|---|---|---|---|---|---|
| No | Ramp Cross Slope LT (%) | 2.3 | No | Ramp Cross Slope RT (%) | 4.8 |

**Remove & Replace Curb Ramp With Two New Directional Ramps or Equivalent.**

**R204.3, R304.5.3, STD 1115**
