# Access Compliance Report Public Rights-of-Way (Curb Ramps)

Main Street: TUDOR\_WAY Cross Street: REGENT\_PARK Location: SW

ADA ID: RPAT211103132619 Ramp Type: Type 4 - Parallel Initial Pass/Fail: Fail Overall Compliance: No Severity Score: 2

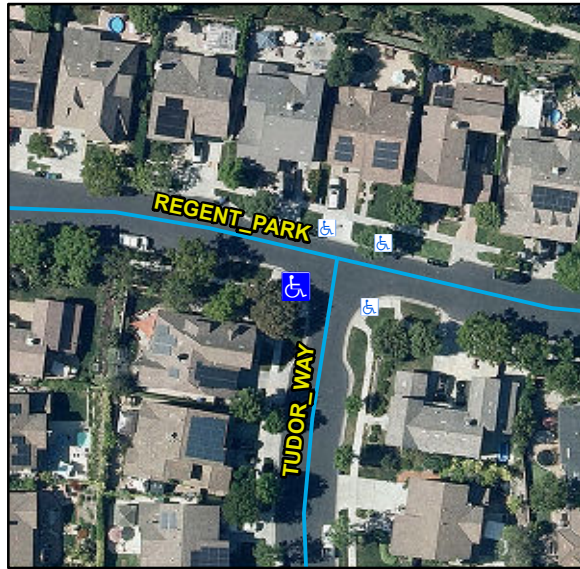
| Compliance | Description | Data | Compliance | Description | Data |
|---|---|---|---|---|---|
| No | Ramp Cross Slope LT (%) | 2.3 | Yes | Ramp Cross Slope RT (%) | 0.5 |
| N/A | Gutter Ponding | N/A | No | Curb Slope | 11.2 |
| N/A | Gutter Cross Slope (%) | N/A | No | Perpendicular Joint Present | No |

**Remove & Replace Curb Ramp With Two New Directional Ramps or Equivalent.**

**R304.2.2, R204.3, R304.5.3, STD 1115**
