# Access Compliance Report Public Rights-of-Way (Curb Ramps)

| Main Street: REGENT_PARK | | Cross Street: TUDOR_WAY | | Location: | SE |
| ADA ID: RPAT211103133046 | Ramp Type: Type 4 - Parallel | Initial Pass/Fail: Fail | Overall Compliance: No | Severity Score: | 2 |

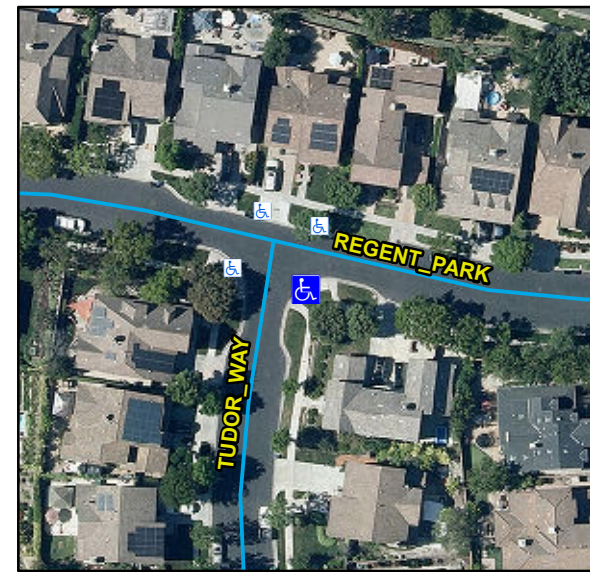
| Compliance | Description | Data | Compliance | Description | Data |
|---|---|---|---|---|---|
| Yes | Ramp Cross Slope LT (%) | 0.5 | No | Ramp Cross Slope RT (%) | 2.4 |

Possible Solutions:

**Remove & Replace Curb Ramp With Two New Directional Ramps or Equivalent.**

**R204.3, R304.5.3, STD 1115**

Total Cost: \$ 4000

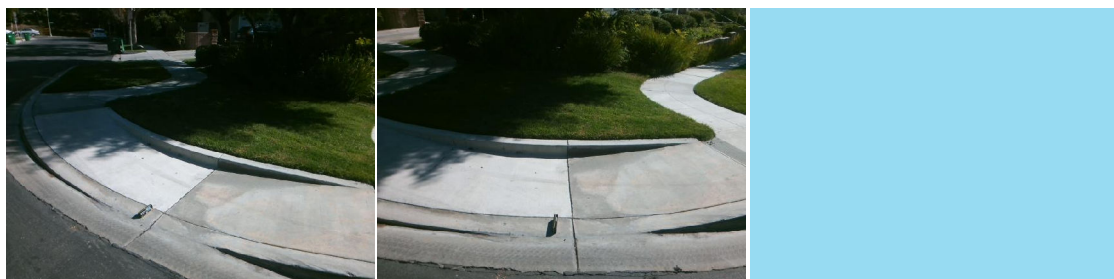
| Compliance | Description | Data | Compliance | Description | Data |
|---|---|---|---|---|---|
| N/A | Ramp Length LT (in) | 105 | N/A | Ramp Length RT (in) | 57 |
| Yes | Ramp Width LT (in) | 48 | Yes | Ramp Width RT (in) | 48 |
| Yes | Ramp Run Slope LT (%) | 7.6 | Yes | Ramp Run Slope RT (%) | 5.2 |
