# Access Compliance Report Public Rights-of-Way (Curb Ramps)

Main Street: CHARDONNAY\_DR Cross Street: REGENT\_PARK Location: SW

ADA ID: RPAT211103133616 Ramp Type: Type 1 - Perpendicular Diagonal Initial Pass/Fail: Pass Overall Compliance: No Severity Score: 22

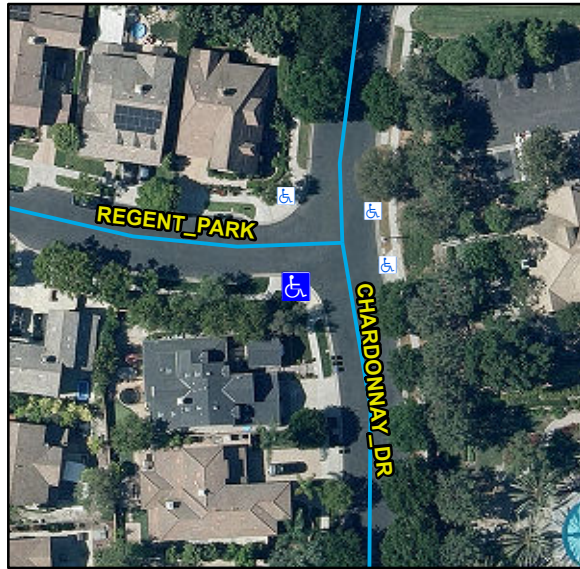
R304.2.2, R204.3, R304.2.1, R304.2.2-Perp, R304.3.2-Para, R304.5.3, R305, STD 1115

Remove & Replace Curb Ramp With Two New Directional Ramps or Equivalent.

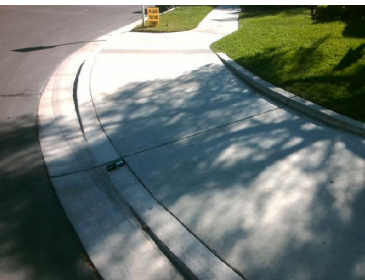
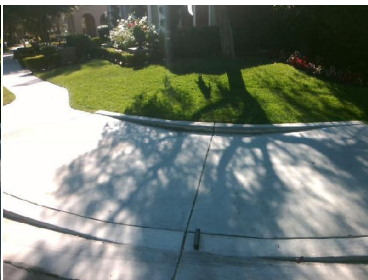
| Compliance | Description | Data | Compliance | Description | Data |
|---|---|---|---|---|---|
| No | Landing Width (in) | N/A | Yes | Flare Slope RT (%) | 5 |
| No | Landing Run Slope (%) | N/A | N/A | Flare Traversable RT | Yes |
| No | Landing Cross Slope (%) | N/A | No | DWS Provided | No |
| Yes | Gutter Ponding | No | No | Curb Slope | 11.3 |
