# Access Compliance Report Public Rights-of-Way (Curb Ramps)

| Main Street: CHARDONNAY_DR | | Cross Street: REGENT_PARK | | Location: | SE |
| ADA ID: RPAT211103134145 | Ramp Type:Type 1 - Perpendicular | Initial Pass/Fail: Fail | Overall Compliance: No | Severity Score: | 16 |

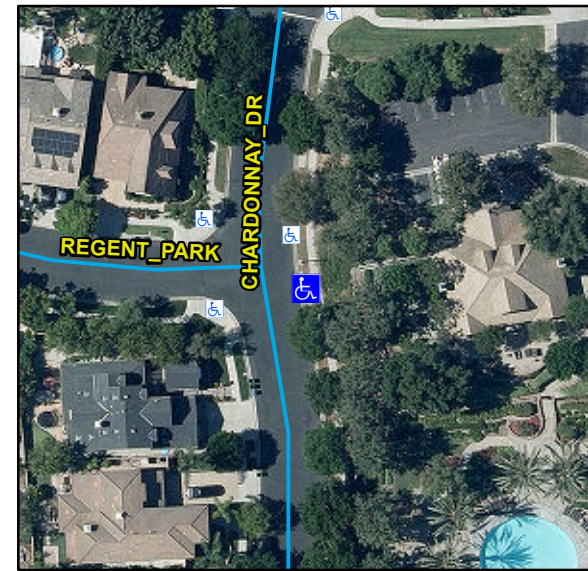
R304.2.2, R204.3, R304.5.3, STD 1115

| Compliance | Description | Data | Compliance | Description | Data |
|---|---|---|---|---|---|
| No | Ramp Run Slope (%) | 8.5 | N/A | Flare Slope LT (%) | N/A |
| No | Ramp Cross Slope (%) | 2.9 | N/A | Flare Traversable LT | N/A |

Remove & Replace Entire Ramp.

Total Cost: \$ 3080
