# Access Compliance Report Public Rights-of-Way (Curb Ramps)

Main Street: **REGENT\_PARK** Cross Street: **CHARDONNAY\_DR** Location: **NW**

ADA ID: **RPAT211103134450** Ramp Type: **Type 1 - Perpendicular Diagonal** Initial Pass/Fail: **Fail** Overall Compliance: **No** Severity Score: **30**

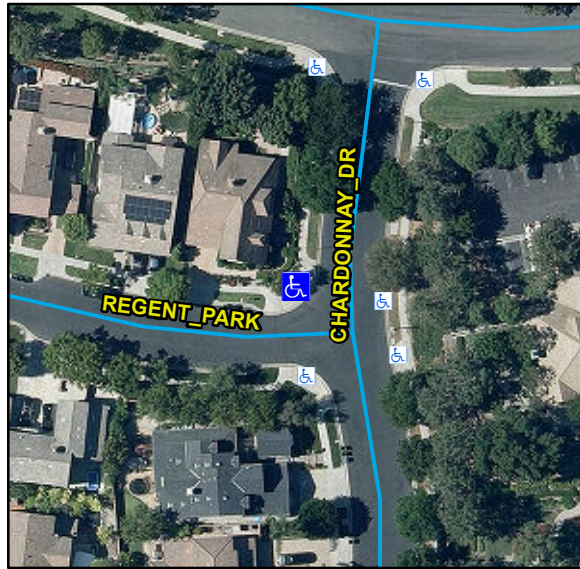
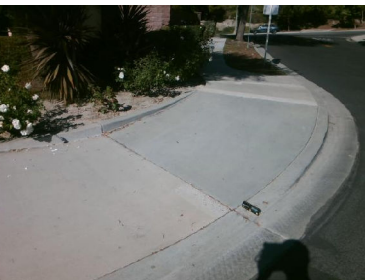
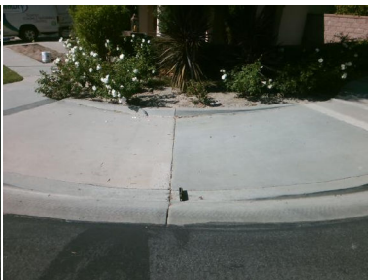
| Compliance | Description | Data | Compliance | Description | Data |
|---|---|---|---|---|---|
| <b>No</b> | Ramp Cross Slope (%) | <b>7.2</b> | <b>N/A</b> | Flare Traversable LT | <b>N/A</b> |
| <b>N/A</b> | Gutter Ponding | <b>N/A</b> | <b>No</b> | Curb Slope | <b>6.3</b> |

**Remove & Replace Curb Ramp With Two New Directional Ramps or Equivalent.**

**R304.2.2, R204.3, R304.5.3, STD 1115**

Total Cost: \$ **6160**
