# Access Compliance Report Public Rights-of-Way (Curb Ramps)

Main Street: ROANOKE\_DR Cross Street: CHARDONNAY\_DR Location: SE

ADA ID: RPAT211103135630 Ramp Type: Type 4 - Parallel Initial Pass/Fail: Fail Overall Compliance: No Severity Score: 32

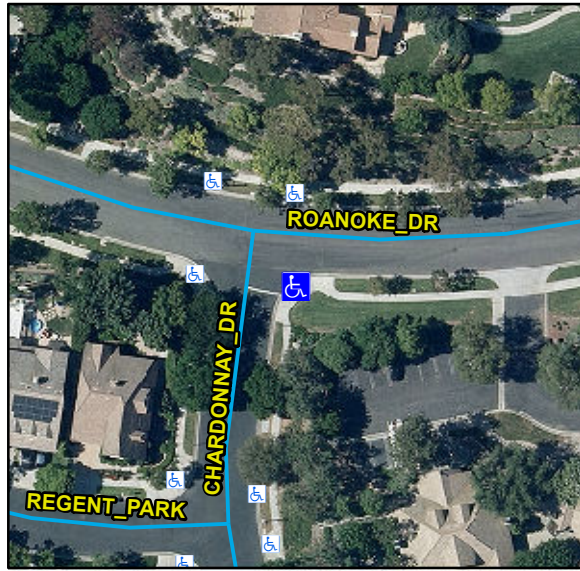
| Compliance | Description | Data | Compliance | Description | Data |
|---|---|---|---|---|---|
| No | Ramp Run Slope LT (%) | 15.4 | No | Ramp Run Slope RT (%) | 9.2 |
| No | Ramp Cross Slope LT (%) | 3.3 | Yes | Ramp Cross Slope RT (%) | 1.1 |

Remove & Replace Curb Ramp With Two New Directional Ramps or Equivalent.
