# Access Compliance Report Public Rights-of-Way (Curb Ramps)

Main Street: DOWNING\_ST Cross Street: KINGSWAY\_DR Location: NW

ADA ID: RPAT211103140649 Ramp Type: Type 4 - Parallel Initial Pass/Fail: Fail Overall Compliance: No Severity Score: 34

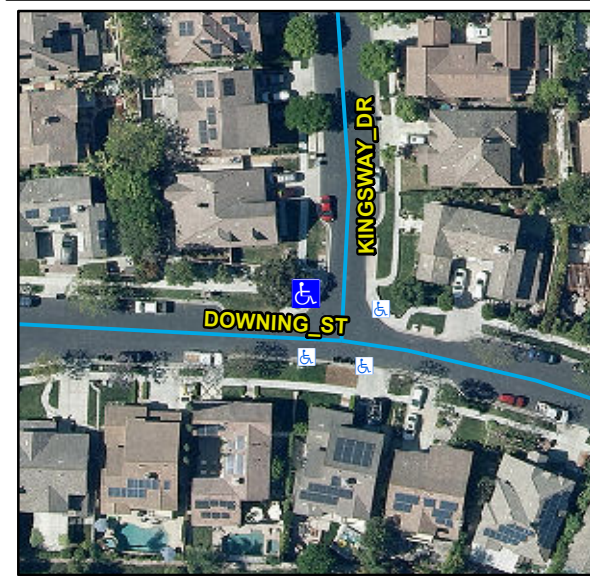
| Compliance | Description | Data | Compliance | Description | Data |
|---|---|---|---|---|---|
| Yes | Ramp Width LT (in) | 48 | No | Ramp Width RT (in) | 47 |
| Yes | Ramp Run Slope LT (%) | 3.8 | No | Ramp Run Slope RT (%) | 11 |
| No | Ramp Cross Slope LT (%) | 5.8 | No | Ramp Cross Slope RT (%) | 3.9 |

Possible Solutions:  
**Remove & Replace Curb Ramp With Two New Directional Ramps or Equivalent.**

OC Std/PROW:  
**R204.3, R304.5.1, R304.5.3, R304.3.2, STD 1115**
