# Access Compliance Report Public Rights-of-Way (Curb Ramps)

Main Street: **KINGSWAY\_DR** Cross Street: **DOWNING\_ST** Location: **NE**

ADA ID: **RPAT211103141023** Ramp Type: **Type 4 - Parallel** Initial Pass/Fail: **Fail** Overall Compliance: **No** Severity Score: **5**

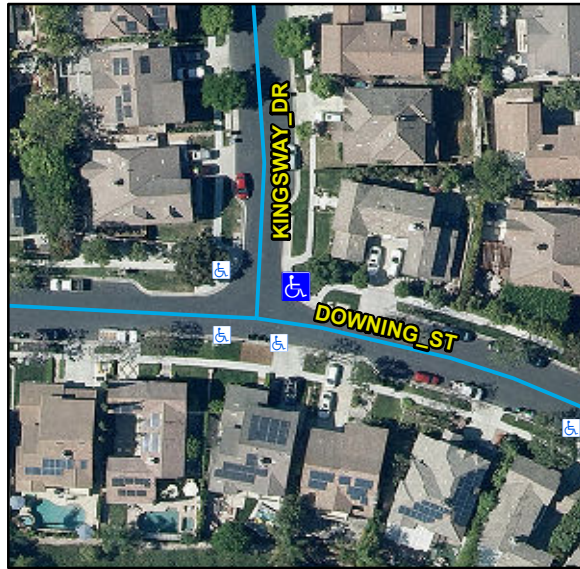
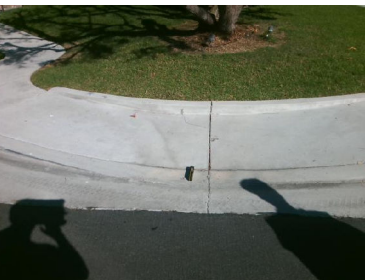
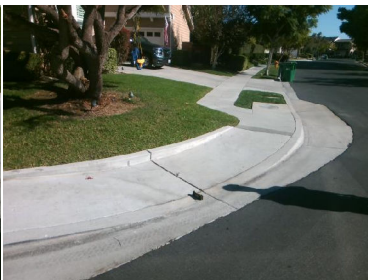
| Compliance | Description | Data | Compliance | Description | Data |
|---|---|---|---|---|---|
| <b>Yes</b> | Ramp Width LT (in) | <b>48</b> | <b>No</b> | Ramp Width RT (in) | <b>47</b> |
| <b>Yes</b> | Ramp Cross Slope LT (%) | <b>1.9</b> | <b>No</b> | Ramp Cross Slope RT (%) | <b>3.2</b> |
| <b>N/A</b> | Gutter Cross Slope (%) | <b>N/A</b> | <b>No</b> | Perpendicular Joint Present | <b>No</b> |

**Remove & Replace Curb Ramp With Two New Directional Ramps or Equivalent.**

**R204.3, R304.5.1, R304.5.3, STD 1115**
