# Access Compliance Report Public Rights-of-Way (Curb Ramps)

| Main Street: WESTFORD_RD | | Cross Street: STRATHMORE | | Location: | N |
| ADA ID: RPAT211103153540 | Ramp Type: Type 4 - Parallel | Initial Pass/Fail: Fail | Overall Compliance: No | Severity Score: | 16 |

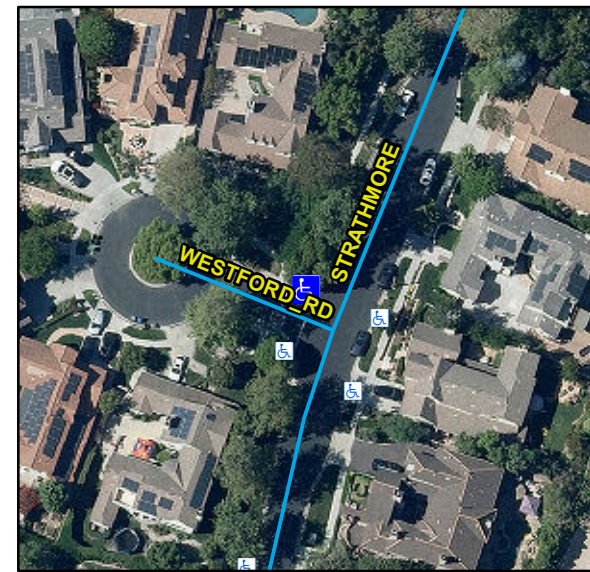
| Compliance | Description | Data | Compliance | Description | Data |
|---|---|---|---|---|---|
| No | Ramp Run Slope LT (%) | 9.5 | Yes | Ramp Run Slope RT (%) | 0.4 |
| No | Ramp Cross Slope LT (%) | 3.6 | Yes | Ramp Cross Slope RT (%) | 0.1 |

**Remove & Replace Curb Ramp With Two New Directional Ramps or Equivalent.**

**R204.3, R304.3.2, R304.5.3, STD 1115**

Total Cost: \$ 4000

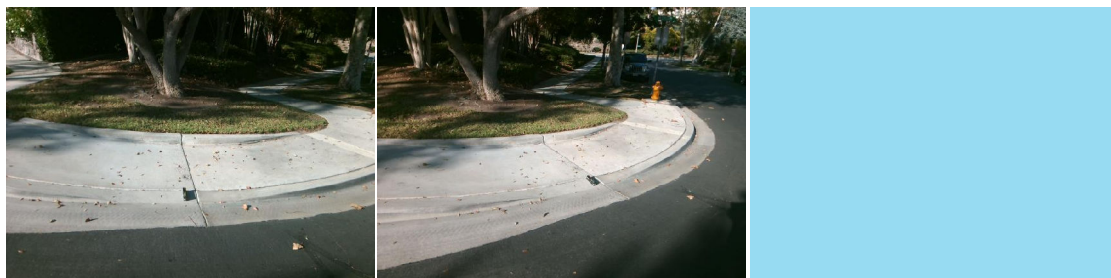
| Compliance | Description | Data | Compliance | Description | Data |
|---|---|---|---|---|---|
| N/A | Ramp Length LT (in) | 95 | N/A | Ramp Length RT (in) | 85 |
| Yes | Ramp Width LT (in) | 52 | Yes | Ramp Width RT (in) | 52 |
