# Access Compliance Report Public Rights-of-Way (Curb Ramps)

Main Street: STRATHMORE Cross Street: WESTFORD\_RD Location: W

ADA ID: RPAT211103153814 Ramp Type: Type 4 - Parallel Initial Pass/Fail: Pass Overall Compliance: No Severity Score: 16

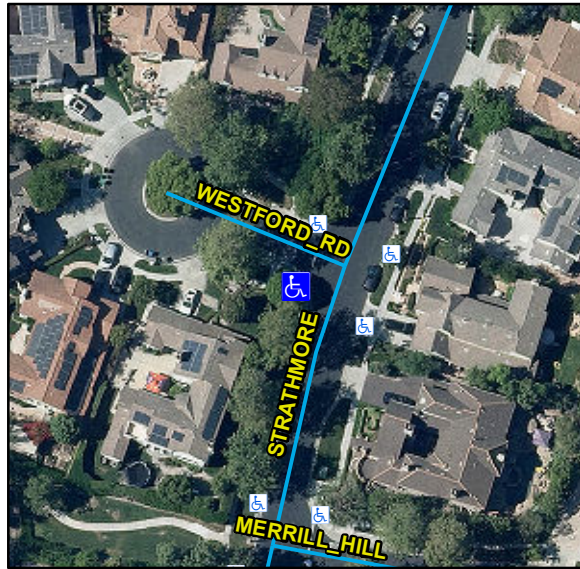
| Compliance | Description | Data | Compliance | Description | Data |
|---|---|---|---|---|---|
| No | Landing Cross Slope (%) | 2.7 | | DWS Offset Type | N/A |
| Yes | Gutter Ponding | No | No | Curb Slope | 13.1 |
| No | Gutter Run Slope (%) | 6.8 | | Road Cross Slope (%) | 0.9 |
| No | Gutter Cross Slope (%) | 2.2 | No | Perpendicular Joint Present | No |

Remove & Replace Curb Ramp With Two New Directional Ramps or Equivalent. Remove & Replace Gutter.

R304.2.2, R204.3, R304.5.3, R305, R304.5.4, STD 1115
