# Access Compliance Report Public Rights-of-Way (Curb Ramps)

Main Street: STRATHMORE Cross Street: MERRILL\_HILL Location: E

ADA ID: RPAT211103154448 Ramp Type: Type 4 - Parallel Initial Pass/Fail: Fail Overall Compliance: No Severity Score: 15

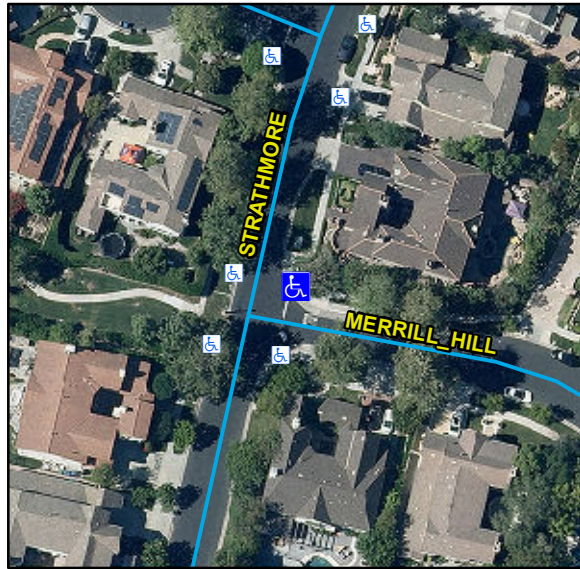
| Compliance | Description | Data | Compliance | Description | Data |
|---|---|---|---|---|---|
| Yes | Ramp Run Slope LT (%) | 1 | No | Ramp Run Slope RT (%) | 10.6 |

**Remove & Replace Curb Ramp With Two New Directional Ramps or Equivalent.**

**R204.3, R304.3.2, STD 1115**
