# Access Compliance Report Public Rights-of-Way (Curb Ramps)

Main Street: MERRILL\_HILL Cross Street: STRATHMORE Location: SE

ADA ID: RPAT211103154836 Ramp Type: Type 4 - Parallel Initial Pass/Fail: Pass Overall Compliance: No Severity Score: 15

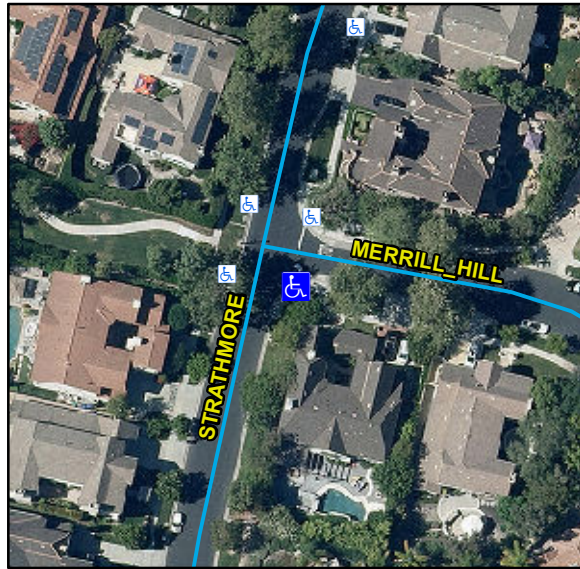
**R304.2.2, R204.3, R305, R304.5.4, STD 1115**

| Compliance | Description | Data | Compliance | Description | Data |
|---|---|---|---|---|---|
| N/A | Landing Present | Yes | No | DWS Provided | No |
| Yes | Gutter Ponding | No | No | Curb Slope | 12.1 |
| No | Gutter Run Slope (%) | 6.9 | | Road Cross Slope (%) | 2.9 |
| Yes | Gutter Cross Slope (%) | 1.2 | No | Perpendicular Joint Present | No |

**Remove & Replace Curb Ramp With Two New Directional Ramps or Equivalent. Remove & Replace Gutter.**
