# Access Compliance Report Public Rights-of-Way (Curb Ramps)

Main Street: FLINTRIDGE\_AVE Cross Street: STRATHMORE Location: S

ADA ID: RPAT211103155537 Ramp Type:Type 1 - Perpendicular Diagonal Initial Pass/Fail: Fail Overall Compliance: No Severity Score: 2

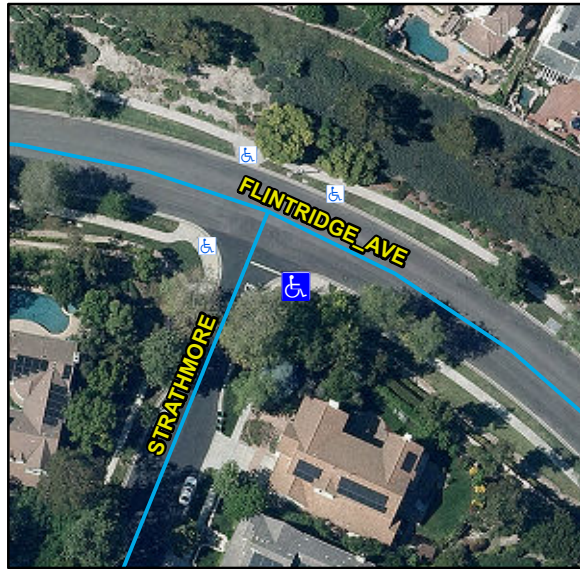
| Compliance | Description | Data | Compliance | Description | Data |
|---|---|---|---|---|---|
| No | Ramp Cross Slope (%) | 2.5 | N/A | Flare Traversable LT | N/A |

Remove & Replace Curb Ramp With Two New Directional Ramps or Equivalent.

R204.3, R304.5.3, STD 1115
