# Access Compliance Report Public Rights-of-Way (Curb Ramps)

Main Street: STRATHMORE Cross Street: FLINTRIDGE\_AVE Location: W

ADA ID: RPAT211103155935 Ramp Type: Type 1 - Perpendicular Diagonal Initial Pass/Fail: Fail Overall Compliance: No Severity Score: 2

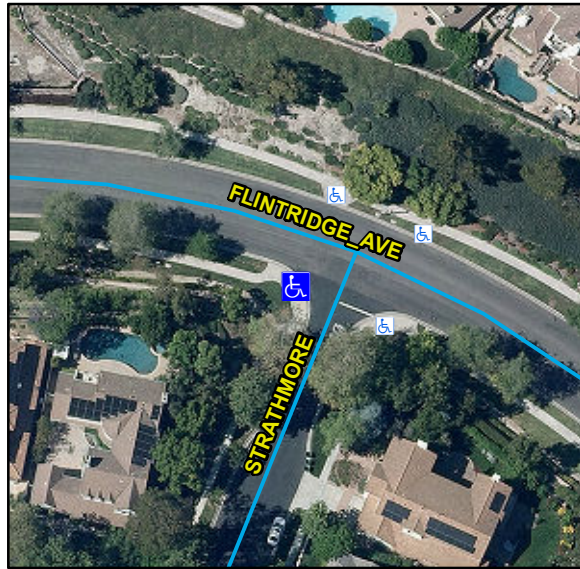
| Compliance | Description | Data | Compliance | Description | Data |
|---|---|---|---|---|---|
| No | Ramp Cross Slope (%) | 3.6 | N/A | Flare Traversable LT | N/A |

Remove & Replace Curb Ramp With Two New Directional Ramps or Equivalent.

R204.3, R304.5.3, STD 1115

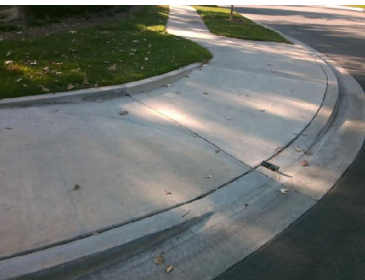
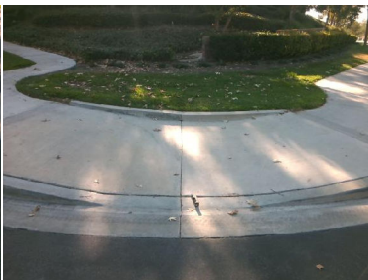
| Compliance | Description | Data | Compliance | Description | Data |
|---|---|---|---|---|---|
| Yes | Overall Surface Condition: Acceptable | | No | Perp Joint Present | No |
