# Access Compliance Report Public Rights-of-Way (Curb Ramps)

| Main Street: FLINTRIDGE_AVE | | Cross Street: STRATHMORE | | Location: | NW |
| ADA ID: RPAT211103160131 | Ramp Type:Type 1 - Perpendicular | Initial Pass/Fail: Pass | Overall Compliance: No | Severity Score: | 16 |

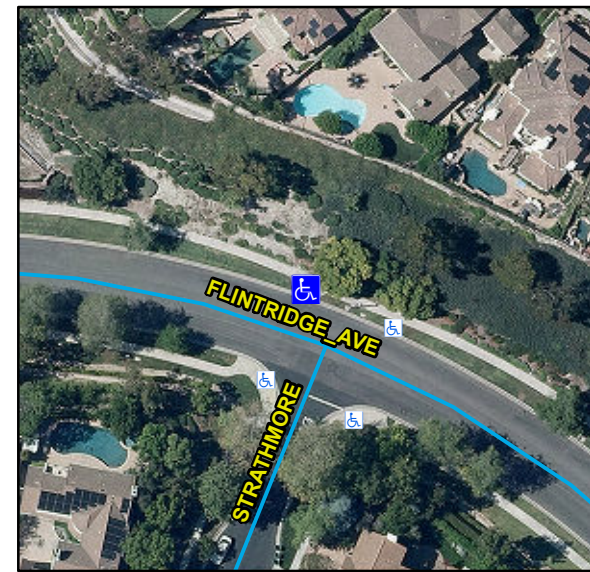
| Compliance | Description | Data | Compliance | Description | Data |
|---|---|---|---|---|---|
| No | Landing Run Slope (%) | 2.6 | N/A | Flare Traversable RT | No |
| Yes | Landing Cross Slope (%) | 1.5 | No | DWS Provided | No |
| Yes | Gutter Ponding | No | No | Curb Slope | 9 |
| No | Gutter Run Slope (%) | 6.7 | | Road Cross Slope (%) | N/A |

Remove & Replace Entire Ramp. Remove & Replace Gutter.

R304.2.2, R304.2.1, R304.2.2-Perp, R304.3.2-Para, R305, R304.5.4, STD 1115
