# Access Compliance Report Public Rights-of-Way (Curb Ramps)

Main Street: CANTAR\_ST Cross Street: SALIENTE\_RD Location: NE

ADA ID: RPAT211104094917 Ramp Type: Type 4 - Parallel Initial Pass/Fail: Fail Overall Compliance: No Severity Score: 30

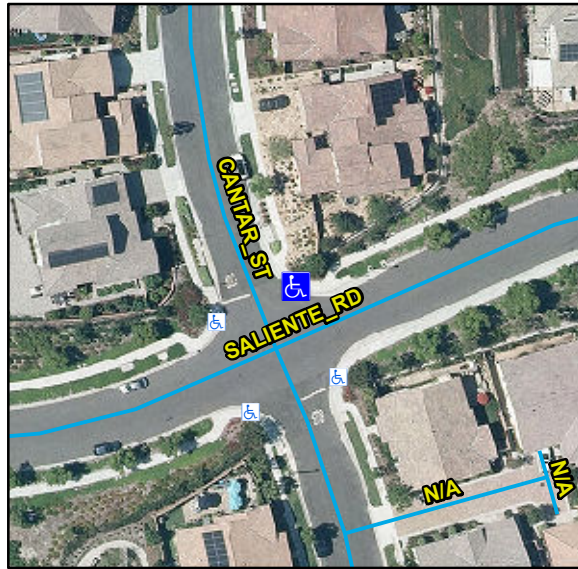
| Compliance | Description | Data | Compliance | Description | Data |
|---|---|---|---|---|---|
| Yes | Ramp Run Slope LT (%) | 0.6 | No | Ramp Run Slope RT (%) | 13.9 |

Remove & Replace Curb Ramp With Two New Directional Ramps or Equivalent.

R304.3.2, STD 1115

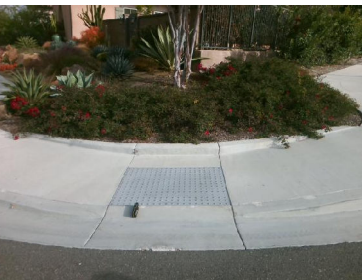
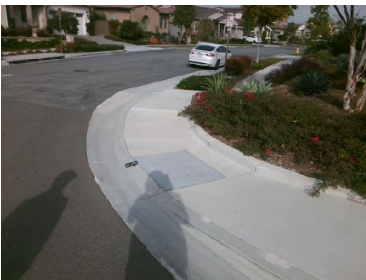
| Compliance | Description | Data | Compliance | Description | Data |
|---|---|---|---|---|---|
| N/A | Gutter Ponding | N/A | N/A | Curb Slope | 13.7 |
