# Access Compliance Report Public Rights-of-Way (Curb Ramps)

Main Street: SALIENTE\_RD Cross Street: CANTAR\_ST Location: NW

ADA ID: RPAT211104095235 Ramp Type: Type 4 - Parallel Initial Pass/Fail: Fail Overall Compliance: No Severity Score: 32

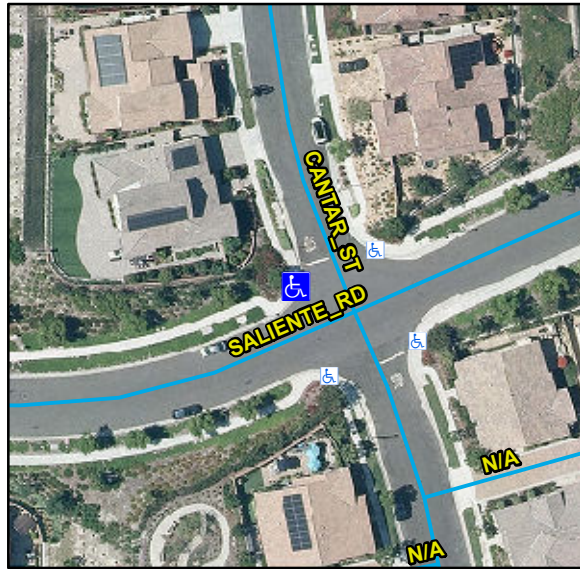
| Compliance | Description | Data | Compliance | Description | Data |
|---|---|---|---|---|---|
| Yes | Ramp Run Slope LT (%) | 4.9 | No | Ramp Run Slope RT (%) | 14.3 |
| Yes | Ramp Cross Slope LT (%) | 0.5 | No | Ramp Cross Slope RT (%) | 2.1 |

Remove & Replace Curb Ramp With Two New Directional Ramps or Equivalent.

R304.3.2, R304.5.3, STD 1115
