# Access Compliance Report Public Rights-of-Way (Curb Ramps)

Main Street: CERRERO\_CT Cross Street: SALIENTE\_RD Location: NE

ADA ID: RPAT211104095649 Ramp Type: Type 4 - Parallel Initial Pass/Fail: Fail Overall Compliance: No Severity Score: 2

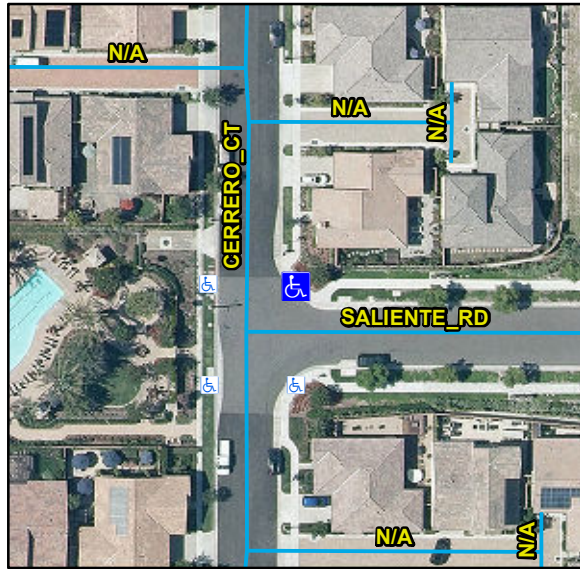
| Compliance | Description | Data | Compliance | Description | Data |
|---|---|---|---|---|---|
| Yes | Ramp Cross Slope LT (%) | 1.5 | No | Ramp Cross Slope RT (%) | 2.3 |

Remove & Replace Curb Ramp With Two New Directional Ramps or Equivalent.

R304.5.3, STD 1115
