# Access Compliance Report Public Rights-of-Way (Curb Ramps)

Main Street: SALIENTE\_RD Cross Street: CERRERO\_CT Location: SE

ADA ID: RPAT211104100317 Ramp Type: Type 4 - Parallel Initial Pass/Fail: Fail Overall Compliance: No Severity Score: 16

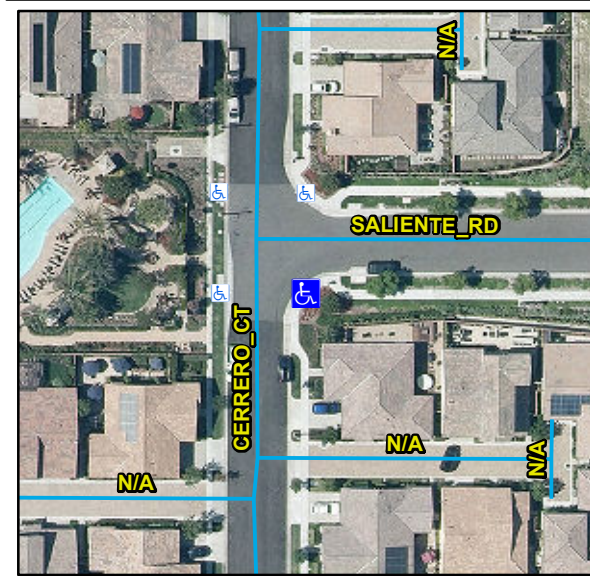
| Compliance | Description | Data | Compliance | Description | Data |
|---|---|---|---|---|---|
| No | Ramp Run Slope LT (%) | 9.4 | Yes | Ramp Run Slope RT (%) | 4 |
| Yes | Ramp Cross Slope LT (%) | 0.2 | No | Ramp Cross Slope RT (%) | 2.4 |

Possible Solutions:  
**Remove & Replace Curb Ramp With Two New Directional Ramps or Equivalent.**

OC Std/PROW:  
**R304.3.2, R304.5.3, STD 1115**

Total Cost: \$ 4000
