# Access Compliance Report Public Rights-of-Way (Curb Ramps)

| Main Street: CANTAR_ST | | Cross Street: SALIENTE_RD | | Location: | SW |
| ADA ID: RPAT211104101020 | Ramp Type: Type 4 - Parallel | Initial Pass/Fail: Fail | Overall Compliance: No | Severity Score: | 32 |

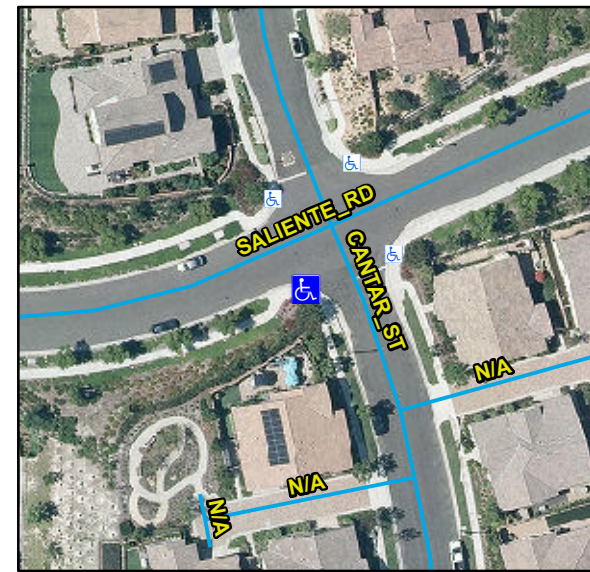
| Compliance | Description | Data | Compliance | Description | Data |
|---|---|---|---|---|---|
| No | Ramp Run Slope LT (%) | 13.8 | Yes | Ramp Run Slope RT (%) | 5.9 |
| No | Ramp Cross Slope LT (%) | 2.9 | No | Ramp Cross Slope RT (%) | 2.8 |

**Remove & Replace Curb Ramp With Two New Directional Ramps or Equivalent.**

**R304.3.2, R304.5.3, STD 1115**

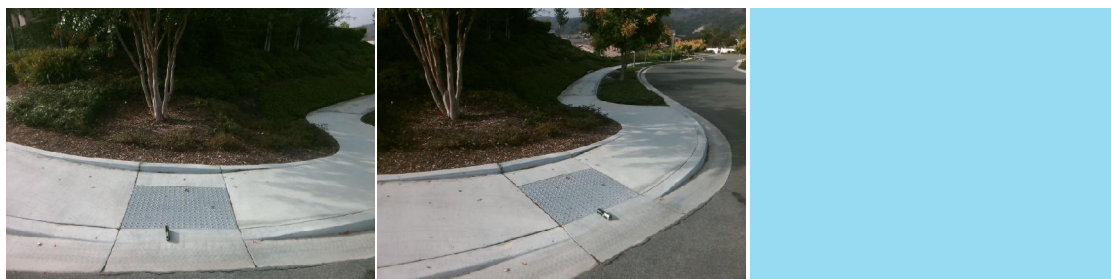
| Compliance | Description | Data | Compliance | Description | Data |
|---|---|---|---|---|---|
| N/A | Ramp Length LT (in) | 107 | N/A | Ramp Length RT (in) | 106 |
| Yes | Ramp Width LT (in) | 53 | Yes | Ramp Width RT (in) | 53 |
