# Access Compliance Report Public Rights-of-Way (Curb Ramps)

Main Street: SALIENTE\_RD Cross Street: CANTAR\_ST Location: SE

ADA ID: RPAT211104101413 Ramp Type: Type 4 - Parallel Initial Pass/Fail: Fail Overall Compliance: No Severity Score: 30

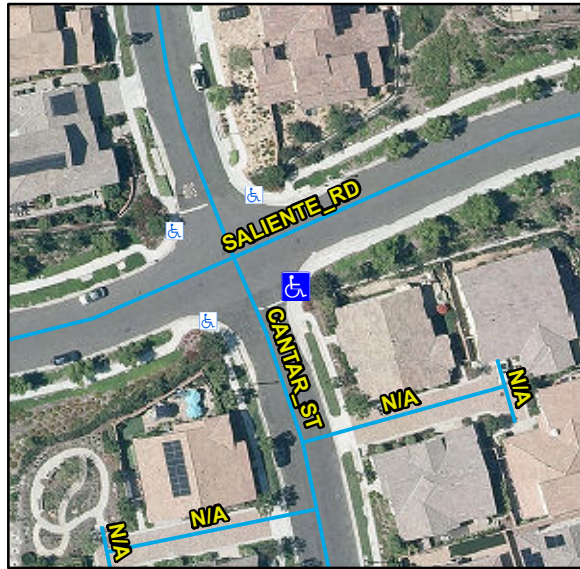
| Compliance | Description | Data | Compliance | Description | Data |
|---|---|---|---|---|---|
| No | Ramp Run Slope LT (%) | 12.1 | Yes | Ramp Run Slope RT (%) | 0.7 |

Remove & Replace Curb Ramp With Two New Directional Ramps or Equivalent.

R304.3.2, STD 1115
