# Access Compliance Report Public Rights-of-Way (Curb Ramps)

| Main Street: SALIENTE_RD | | Cross Street: ALAR_ST | | Location: | NW |
| ADA ID: RPAT211104101850 | Ramp Type: Type 4 - Parallel | Initial Pass/Fail: Fail | Overall Compliance: No | Severity Score: | 32 |

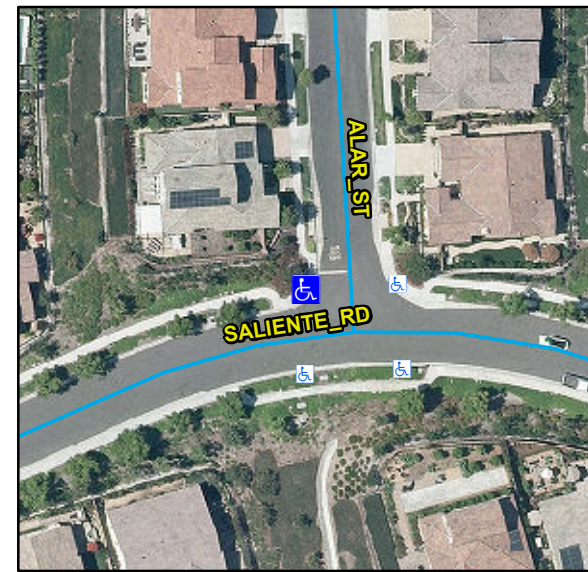
| Compliance | Description | Data | Compliance | Description | Data |
|---|---|---|---|---|---|
| Yes | Ramp Run Slope LT (%) | 4.8 | No | Ramp Run Slope RT (%) | 13.5 |
| No | Ramp Cross Slope LT (%) | 2.4 | Yes | Ramp Cross Slope RT (%) | 1.2 |

**Remove & Replace Curb Ramp With Two New Directional Ramps or Equivalent.**

**R304.5.3, R304.3.2, STD 1115**

Total Cost: \$ 4000

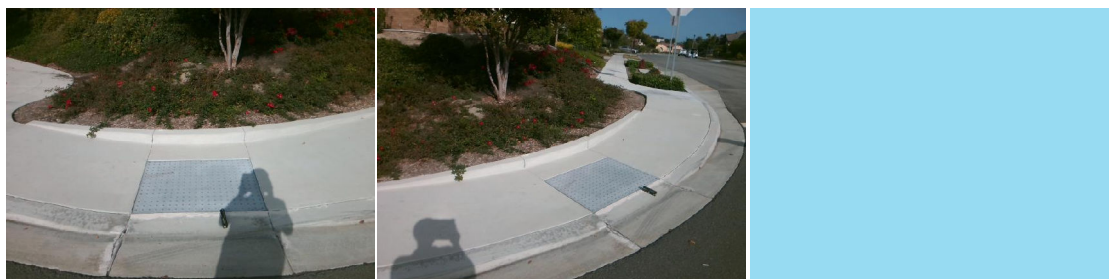
| Compliance | Description | Data | Compliance | Description | Data |
|---|---|---|---|---|---|
| | Crossing 1 Slope (%) | 1.6 | | Crossing 2 Slope (%) | 8.7 |
| | Crossing 1 Cross Slope (%) | 9.5 | | Crossing 2 Cross Slope (%) | 1.7 |
