# Access Compliance Report Public Rights-of-Way (Curb Ramps)

Main Street: ALAR\_ST Cross Street: SALIENTE\_RD Location: NE

ADA ID: RPAT211104102117 Ramp Type: Type 4 - Parallel Initial Pass/Fail: Fail Overall Compliance: No Severity Score: 15

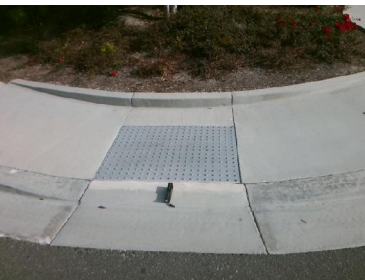
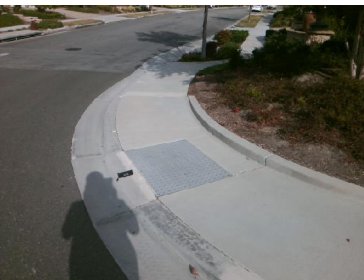
| Compliance | Description | Data | Compliance | Description | Data |
|---|---|---|---|---|---|
| Yes | Ramp Run Slope LT (%) | 0.5 | No | Ramp Run Slope RT (%) | 11.9 |

**Remove & Replace Curb Ramp With Two New Directional Ramps or Equivalent.**

**R304.3.2, STD 1115**
