# Access Compliance Report Public Rights-of-Way (Curb Ramps)

Main Street: RISA\_ST Cross Street: SALIENTE\_RD Location: E

ADA ID: RPAT211104103005 Ramp Type: Type 4 - Parallel Initial Pass/Fail: Pass Overall Compliance: No Severity Score: 0

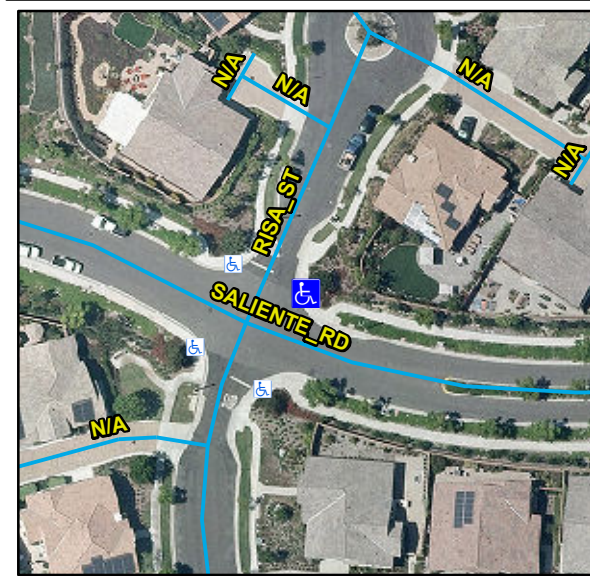
| Compliance | Description | Data | Compliance | Description | Data |
|---|---|---|---|---|---|
| No | Landing Run Slope (%) | 2.4 | Yes | DWS Full Width | Yes |

Possible Solutions:  
**Remove & Replace Landing.**

OC Std/PROW:  
**R304.2.2-Perp, R304.3.2-Para, STD 1115**

Total Cost: \$ 531
