# Access Compliance Report Public Rights-of-Way (Curb Ramps)

Main Street: SALIENTE\_RD Cross Street: RISA\_ST Location: N

ADA ID: RPAT211104104323 Ramp Type: Type 4 - Parallel Initial Pass/Fail: Pass Overall Compliance: No Severity Score: 0

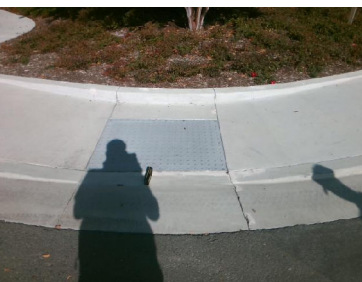
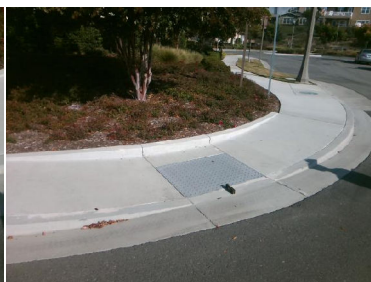
| Compliance | Description | Data | Compliance | Description | Data |
|---|---|---|---|---|---|
| No | Landing Cross Slope (%) | 3.9 | | DWS Offset Type | Single |

Remove & Replace Landing.
