# Access Compliance Report Public Rights-of-Way (Curb Ramps)

Main Street: RISA\_ST Cross Street: SALIENTE\_RD Location: W

ADA ID: RPAT211104104709 Ramp Type: Type 4 - Parallel Initial Pass/Fail: Fail Overall Compliance: No Severity Score: 15

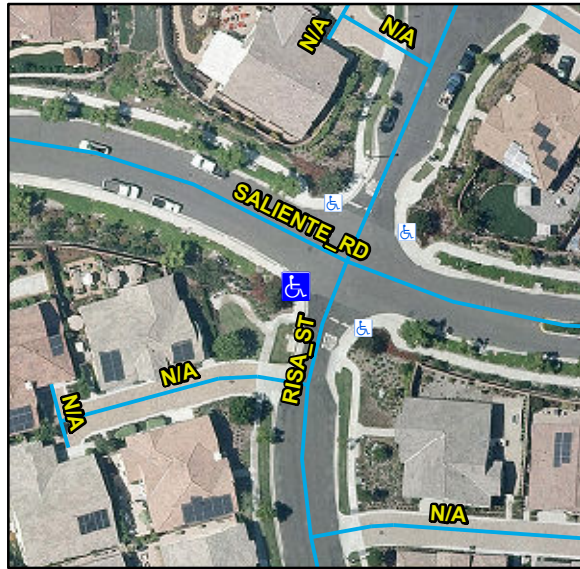
| Compliance | Description | Data | Compliance | Description | Data |
|---|---|---|---|---|---|
| No | Ramp Run Slope LT (%) | 9 | Yes | Ramp Run Slope RT (%) | 1.2 |

**Remove & Replace Curb Ramp With Two New Directional Ramps or Equivalent.**

**R304.3.2, STD 1115**
