# Access Compliance Report Public Rights-of-Way (Curb Ramps)

Main Street: SALIENTE\_RD Cross Street: RISA\_ST Location: S

ADA ID: RPAT211104104910 Ramp Type: Type 4 - Parallel Initial Pass/Fail: Pass Overall Compliance: No Severity Score: 0

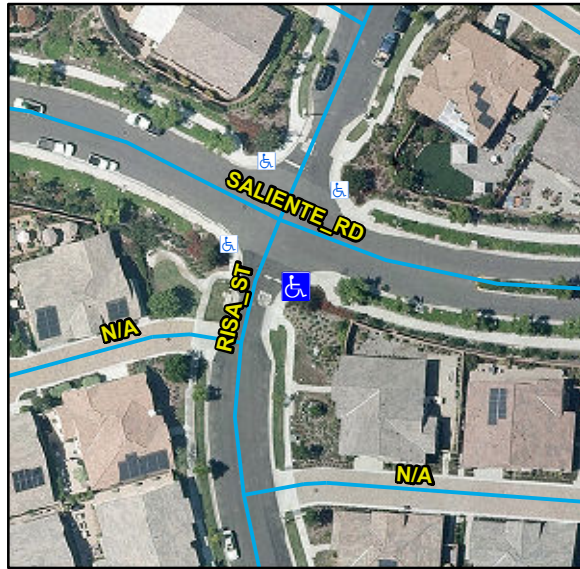
| Compliance | Description | Data | Compliance | Description | Data |
|---|---|---|---|---|---|
| No | Landing Run Slope (%) | 2.5 | Yes | DWS Full Width | Yes |
| Yes | Gutter Ponding | No | No | Curb Slope | 8.7 |
| No | Gutter Cross Slope (%) | 2.4 | Yes | Perpendicular Joint Present | Yes |

Remove & Replace Curb Ramp With Two New Directional Ramps or Equivalent. Remove & Replace Gutter.
