# Access Compliance Report Public Rights-of-Way (Curb Ramps)

| Main Street: ESENCIA_DR | | Cross Street: SALIENTE_RD | | Location: | SW |
| ADA ID: RPAT211104105259 | Ramp Type:Type 1 - Perpendicular Diagonal Initial Pass/Fail: Fail | | Overall Compliance: No | Severity Score: | 15 |

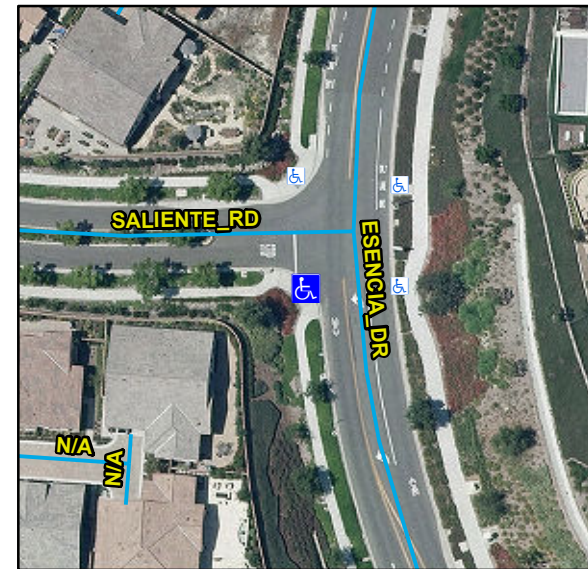
| Compliance | Description | Data | Compliance | Description | Data |
|---|---|---|---|---|---|
| <b>No</b> | Ramp Cross Slope (%) | <b>5.8</b> | <b>N/A</b> | Flare Traversable LT | <b>N/A</b> |
| <b>N/A</b> | Gutter Ponding | <b>N/A</b> | <b>No</b> | Curb Slope | <b>11.6</b> |

Possible Solutions:  
**Remove & Replace Curb Ramp With Two New Directional Ramps or Equivalent.**

OC Std/PROW:  
**R304.2.2, R304.5.3, STD 1115**

Total Cost: \$ **6160**
