# Access Compliance Report Public Rights-of-Way (Curb Ramps)

Main Street: SOLIDO\_ST Cross Street: ARADA\_ST Location: NW

ADA ID: RPAT211104112406 Ramp Type: Type 1 - Perpendicular Diagonal Initial Pass/Fail: Pass Overall Compliance: No Severity Score: 2

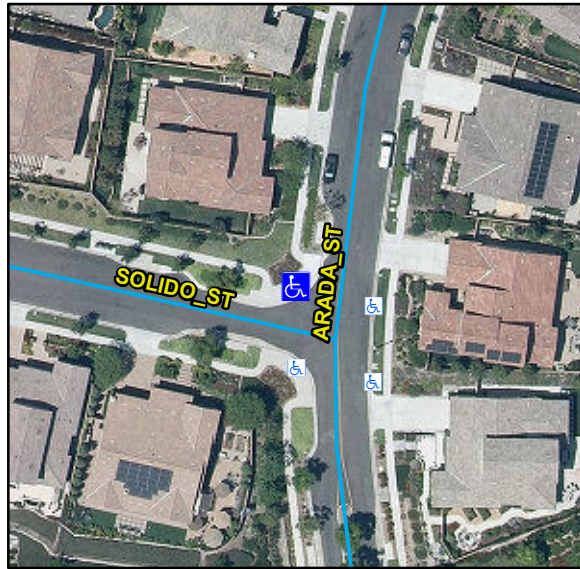
| Compliance | Description | Data | Compliance | Description | Data |
|---|---|---|---|---|---|
| No | Landing Run Slope (%) | 2.2 | N/A | Flare Traversable RT | No |

Remove & Replace Landing.

Total Cost: \$ 531
