# Access Compliance Report Public Rights-of-Way (Curb Ramps)

Main Street: ARADA\_ST Cross Street: SOLIDO\_ST Location: SW

ADA ID: RPAT211104112846 Ramp Type: Type 1 - Perpendicular Diagonal Initial Pass/Fail: Pass Overall Compliance: No Severity Score: 10

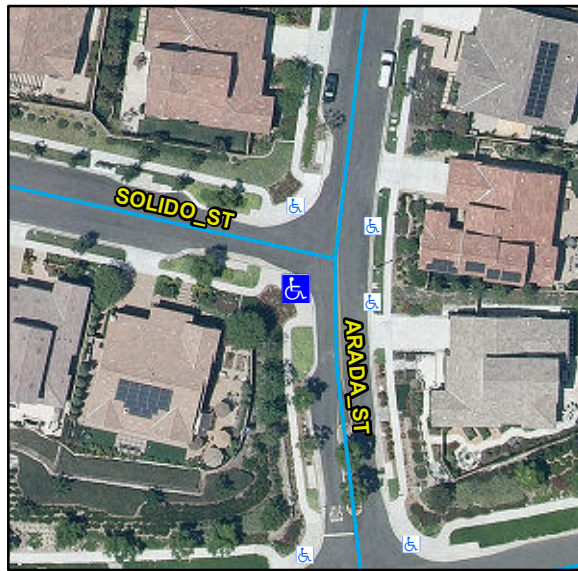
| Compliance | Description | Data | Compliance | Description | Data |
|---|---|---|---|---|---|
| No | Ramp Cross Slope (%) | 2.7 | N/A | Flare Traversable LT | No |
| No | Landing Width (in) | 46 | N/A | Flare Slope RT (%) | 4.8 |
| No | Gutter Run Slope (%) | 5.9 | | Road Cross Slope (%) | 2.8 |

Remove & Replace Curb Ramp With Two New Directional Ramps or Equivalent. Remove & Replace Gutter.

R304.5.3, R304.2.1, R304.5.4, STD 1115
