# Access Compliance Report Public Rights-of-Way (Curb Ramps)

Main Street: AIROSO\_ST Cross Street: ARADA\_ST Location: NW

ADA ID: RPAT211104113356 Ramp Type: Type 4 - Parallel Initial Pass/Fail: Fail Overall Compliance: No Severity Score: 30

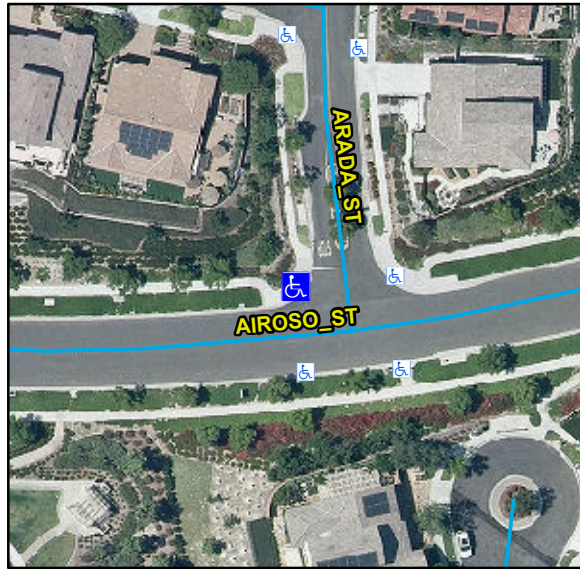
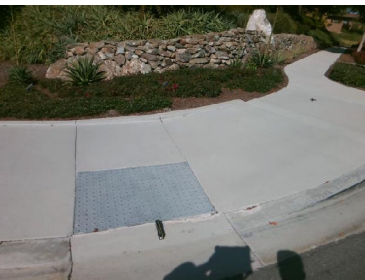
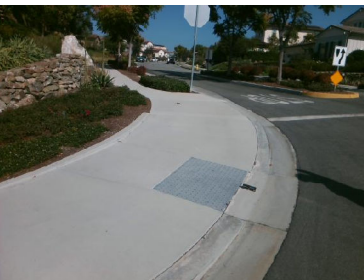
| Compliance | Description | Data | Compliance | Description | Data |
|---|---|---|---|---|---|
| No | Ramp Run Slope LT (%) | 9.5 | No | Ramp Run Slope RT (%) | 16.5 |

**Remove & Replace Curb Ramp With Two New Directional Ramps or Equivalent.**

**R304.3.2, STD 1115**
