# Access Compliance Report Public Rights-of-Way (Curb Ramps)

Main Street: ARADA\_ST Cross Street: AIROSO\_ST Location: NE

ADA ID: RPAT211104113657 Ramp Type: Type 1 - Perpendicular Diagonal Initial Pass/Fail: Fail Overall Compliance: No Severity Score: 15

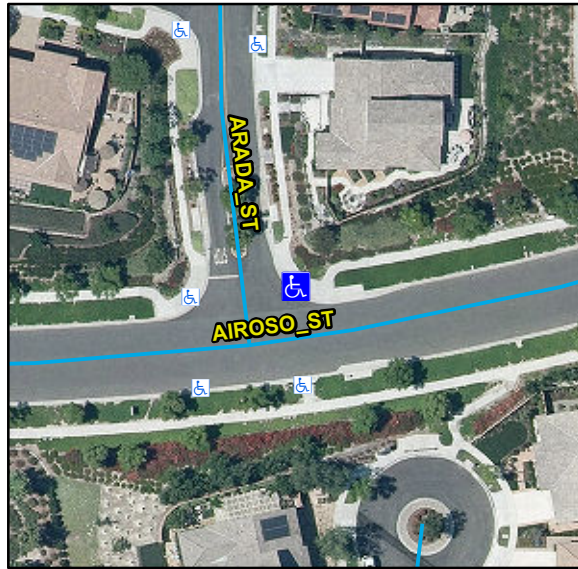
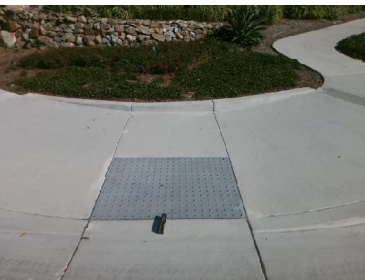
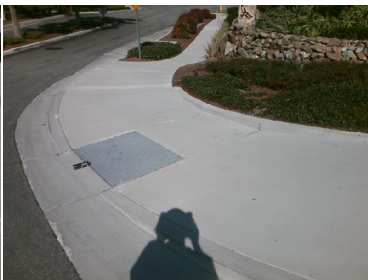
| Compliance | Description | Data | Compliance | Description | Data |
|---|---|---|---|---|---|
| No | Ramp Cross Slope (%) | 6.4 | N/A | Flare Traversable LT | N/A |

**Remove & Replace Curb Ramp With Two New Directional Ramps or Equivalent.**

**R304.5.3, STD 1115**
