# Access Compliance Report Public Rights-of-Way (Curb Ramps)

| Main Street: AIROSO_ST | | Cross Street: ARADA_ST | | Location: | SE |
| ADA ID: RPAT211104113928 | Ramp Type:Type 1 - Perpendicular | Initial Pass/Fail: Pass | Overall Compliance: No | Severity Score: | 24 |

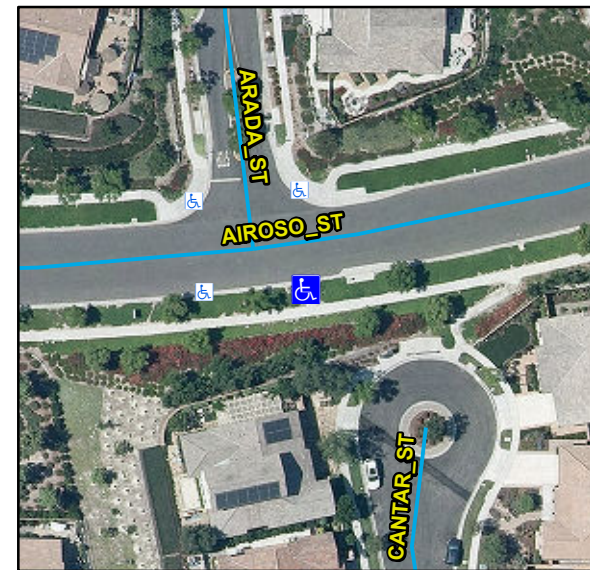
| Compliance | Description | Data | Compliance | Description | Data |
|---|---|---|---|---|---|
| No | Ramp Cross Slope (%) | 6.1 | N/A | Flare Traversable LT | No |
| No | Landing Run Slope (%) | 5.9 | N/A | Flare Traversable RT | No |
| No | Landing Cross Slope (%) | 6.9 | Yes | DWS Provided | Yes |
| No | Gutter Cross Slope (%) | 9.5 | | | |

Possible Solutions:

**Remove & Replace Entire Ramp. Remove & Replace Gutter.**

**R304.2.2, R304.5.3, R304.2.1, R304.2.2-Perp, R304.3.2-Para, STD 1115**

Total Cost: \$ 3332

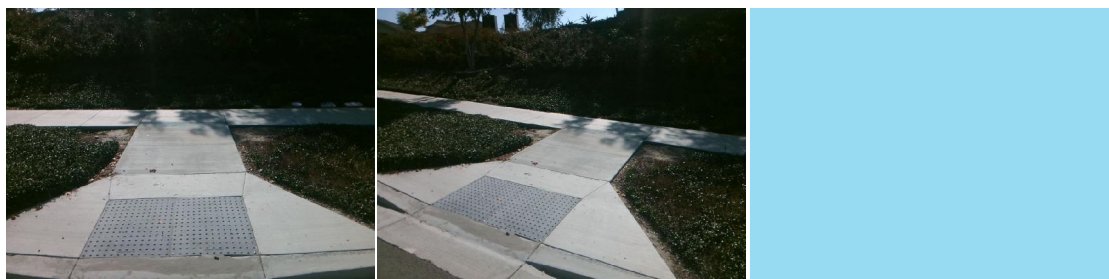
| Compliance | Description | Data | Compliance | Description | Data |
| N/A | Ramp Length (in) | 59 | N/A | Flare Type LT | |
| Yes | Ramp Width (in) | 60 | | | Sloped |
| Yes | Ramp Run Slope (%) | 5.3 | N/A | Flare Slope LT (%) | 20 |
| Yes | Gutter Ponding | No | No | Curb Slope | 12.2 |
