# Access Compliance Report Public Rights-of-Way (Curb Ramps)

| Main Street: WELDON_HEIGHTS | | Cross Street: BENNINGTON_PATH | | Location: | SE |
| ADA ID: RPAT211104130940 | Ramp Type: Type 4 - Parallel | Initial Pass/Fail: Fail | Overall Compliance: No | Severity Score: | 16 |

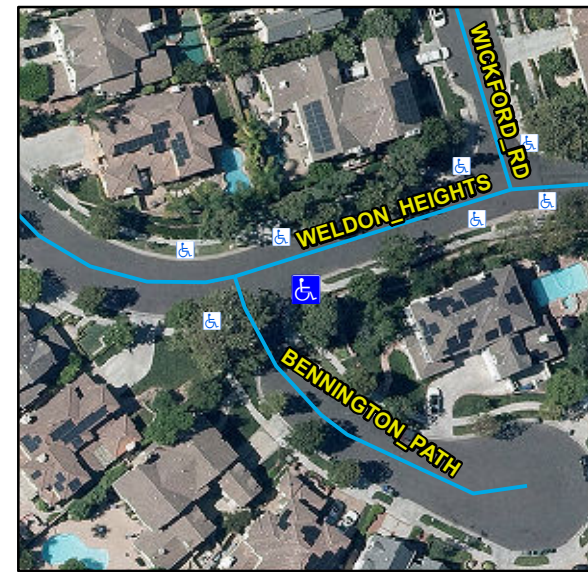
| Compliance | Description | Data | Compliance | Description | Data |
|---|---|---|---|---|---|
| Yes | Ramp Run Slope LT (%) | 2.7 | No | Ramp Run Slope RT (%) | 9.6 |
| No | Ramp Cross Slope LT (%) | 2.7 | Yes | Ramp Cross Slope RT (%) | 1.6 |

**Remove & Replace Curb Ramp With Two New Directional Ramps or Equivalent.**

**R304.5.3, R304.3.2, STD 1115**

Total Cost: \$ 4000

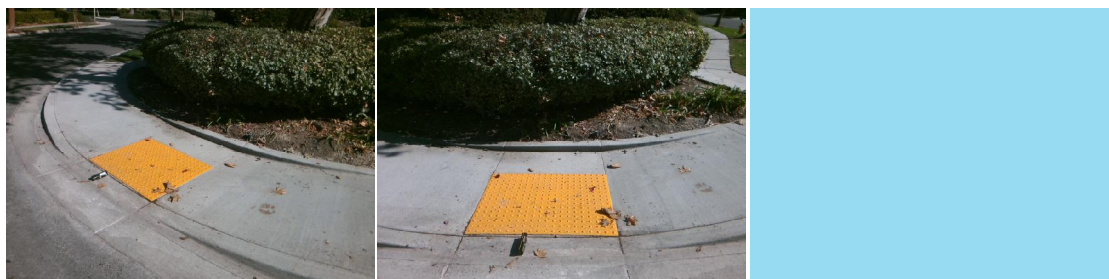
| Compliance | Description | Data | Compliance | Description | Data |
|---|---|---|---|---|---|
| N/A | Ramp Length LT (in) | 84 | N/A | Ramp Length RT (in) | 78 |
| Yes | Ramp Width LT (in) | 58 | Yes | Ramp Width RT (in) | 58 |
