# Access Compliance Report Public Rights-of-Way (Curb Ramps)

Main Street: BENNINGTON\_PATH Cross Street: WELDON\_HEIGHTS Location: SW

ADA ID: RPAT211104131213 Ramp Type: Type 4 - Parallel Initial Pass/Fail: Fail Overall Compliance: No Severity Score: 16

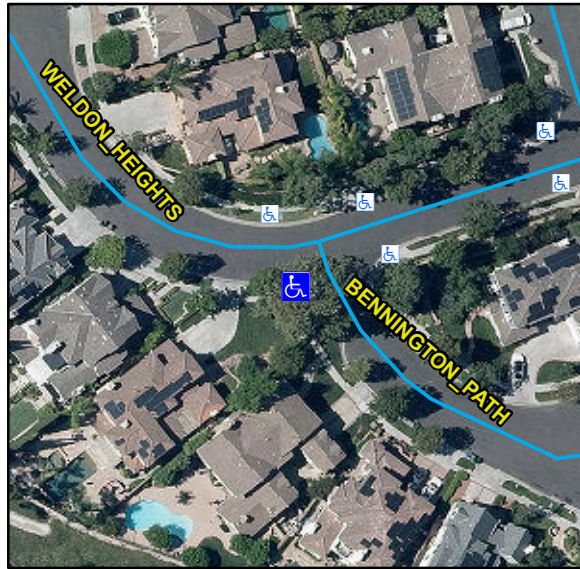
| Compliance | Description | Data | Compliance | Description | Data |
|---|---|---|---|---|---|
| Yes | Ramp Run Slope LT (%) | 5.7 | No | Ramp Run Slope RT (%) | 9.2 |
| No | Ramp Cross Slope LT (%) | 2.7 | Yes | Ramp Cross Slope RT (%) | 1.5 |

Remove & Replace Curb Ramp With Two New Directional Ramps or Equivalent.

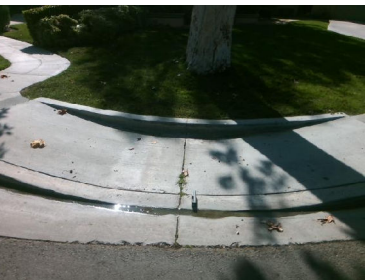
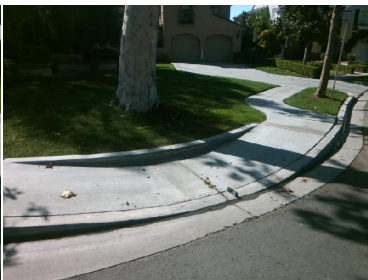
| Compliance | Description | Data | Compliance | Description | Data |
|---|---|---|---|---|---|
| N/A | Gutter Cross Slope (%) | N/A | No | Perpendicular Joint Present | No |
