# Access Compliance Report Public Rights-of-Way (Curb Ramps)

Main Street: WELDON HEIGHTS Cross Street: BENNINGTON\_PATH Location: NE

ADA ID: RPAT211104131428 Ramp Type: Type 1 - Perpendicular Initial Pass/Fail: Pass Overall Compliance: No Severity Score: 21

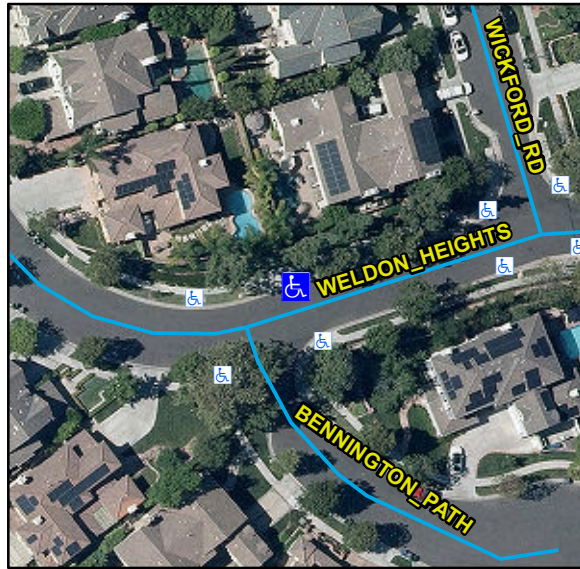
| Compliance | Description | Data | Compliance | Description | Data |
|---|---|---|---|---|---|
| No | Landing Run Slope (%) | 2.4 | N/A | Flare Traversable RT | No |
| Yes | Landing Cross Slope (%) | 0.7 | No | DWS Provided | No |
| Yes | Gutter Ponding | No | No | Curb Slope | 8.3 |
| No | Gutter Run Slope (%) | 5.2 | | Road Cross Slope (%) | N/A |

Remove & Replace Entire Ramp. Remove & Replace Gutter.
