# Access Compliance Report Public Rights-of-Way (Curb Ramps)

Main Street: WELDON\_HEIGHTS Cross Street: WICKFORD\_RD Location: NW

ADA ID: RPAT211104131711 Ramp Type: Type 4 - Parallel Initial Pass/Fail: Fail Overall Compliance: No Severity Score: 15

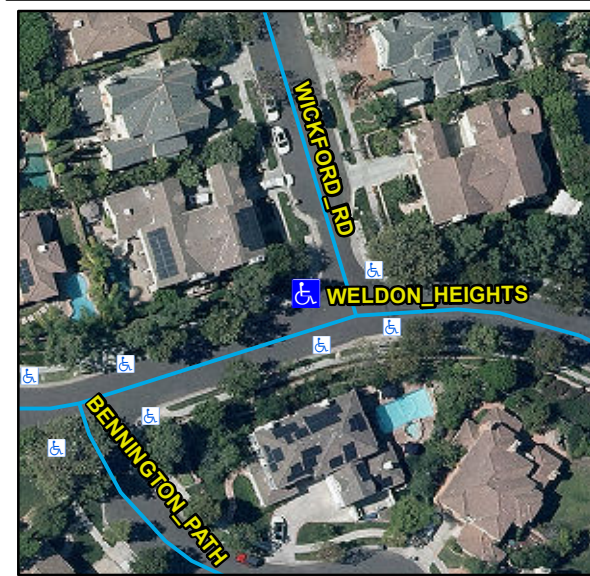
| Compliance | Description | Data | Compliance | Description | Data |
|---|---|---|---|---|---|
| No | Ramp Run Slope LT (%) | 9 | Yes | Ramp Run Slope RT (%) | 7.9 |

Possible Solutions:  
**Remove & Replace Curb Ramp With Two New Directional Ramps or Equivalent.**

OC Std/PROW:  
**R204.3, R304.3.2, STD 1115**
