# Access Compliance Report Public Rights-of-Way (Curb Ramps)

| Main Street: WICKFORD_RD | | Cross Street: WELDON_HEIGHTS | | Location: | NE |
| ADA ID: RPAT211104131909 | Ramp Type: Type 4 - Parallel | Initial Pass/Fail: Fail | Overall Compliance: No | Severity Score: | 15 |

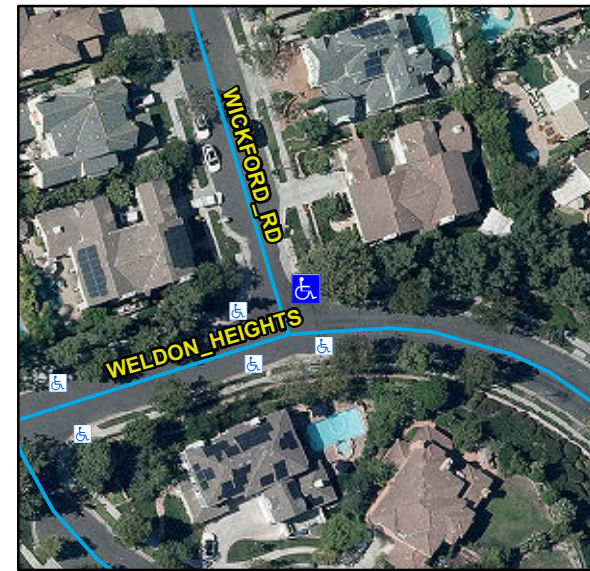
| Compliance | Description | Data | Compliance | Description | Data |
|---|---|---|---|---|---|
| No | Ramp Run Slope LT (%) | 9 | Yes | Ramp Run Slope RT (%) | 5.3 |

**Remove & Replace Curb Ramp With Two New Directional Ramps or Equivalent.**

**R204.3, R304.3.2, STD 1115**

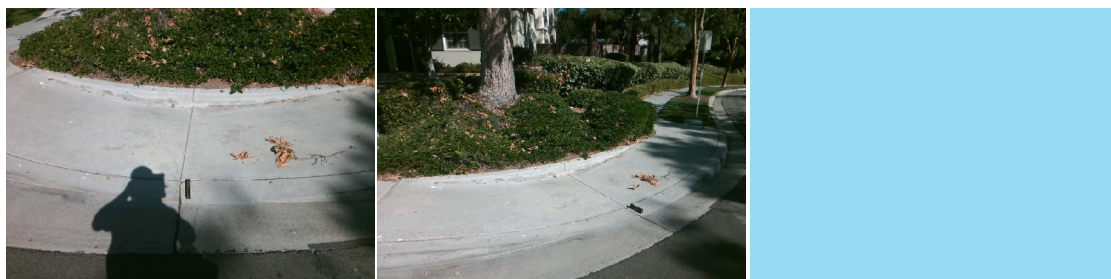
| Compliance | Description | Data | Compliance | Description | Data |
|---|---|---|---|---|---|
| N/A | Ramp Length LT (in) | 82 | N/A | Ramp Length RT (in) | 80 |
| Yes | Ramp Width LT (in) | 54 | Yes | Ramp Width RT (in) | 54 |
| Yes | Ramp Cross Slope LT (%) | 1 | Yes | Ramp Cross Slope RT (%) | 1.5 |
