# Access Compliance Report Public Rights-of-Way (Curb Ramps)

Main Street: WELDON\_HEIGHTS Cross Street: NEWKIRK\_RD Location: NE

ADA ID: RPAT211104132245 Ramp Type: Type 4 - Parallel Initial Pass/Fail: Fail Overall Compliance: No Severity Score: 16

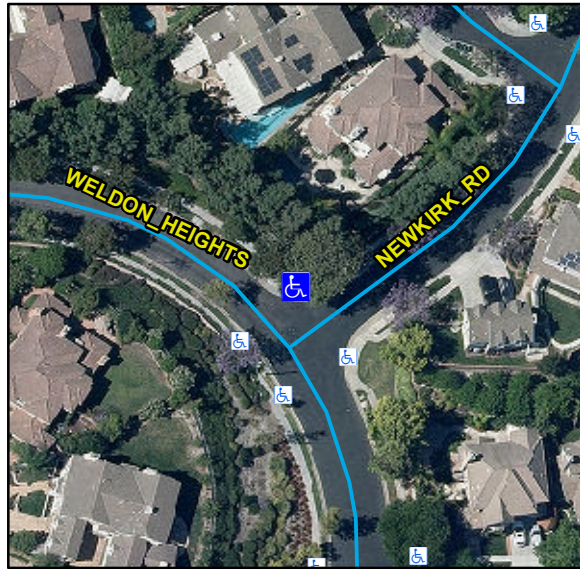
| Compliance | Description | Data | Compliance | Description | Data |
|---|---|---|---|---|---|
| No | Ramp Run Slope LT (%) | 11.3 | Yes | Ramp Run Slope RT (%) | 4.1 |
| Yes | Ramp Cross Slope LT (%) | 0.4 | No | Ramp Cross Slope RT (%) | 2.8 |
| N/A | Gutter Cross Slope (%) | N/A | No | Perpendicular Joint Present | No |

Remove & Replace Curb Ramp With Two New Directional Ramps or Equivalent.

R204.3, R304.3.2, R304.5.3, STD 1115
